Waiari Kaitiaki Advisory Group

CULTURAL RECOGNITION

SITE VISIT JANUARY 2024

PRELIMINARY REPORT

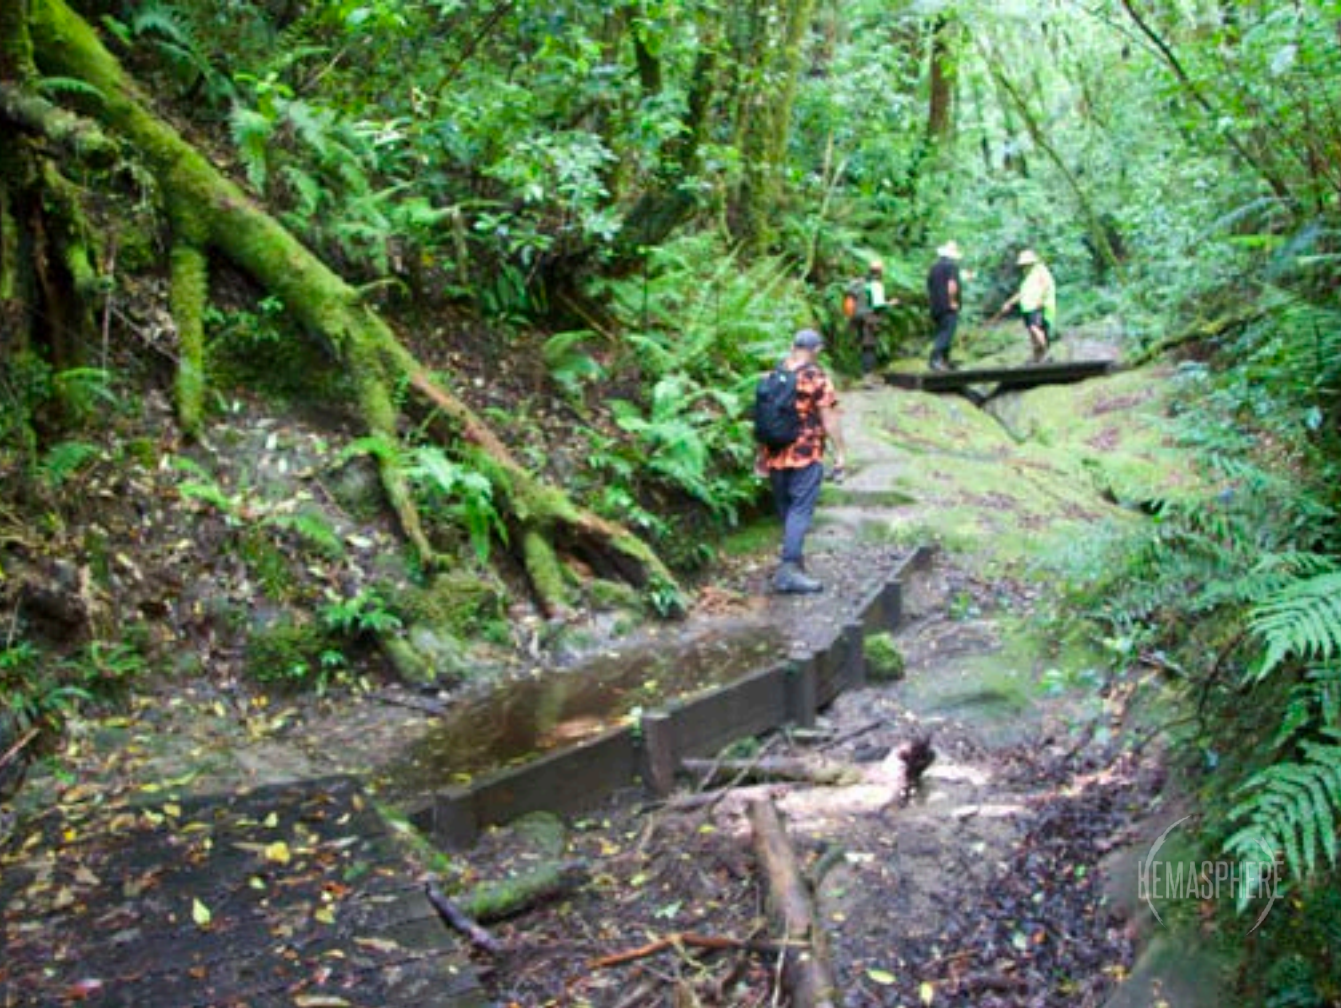
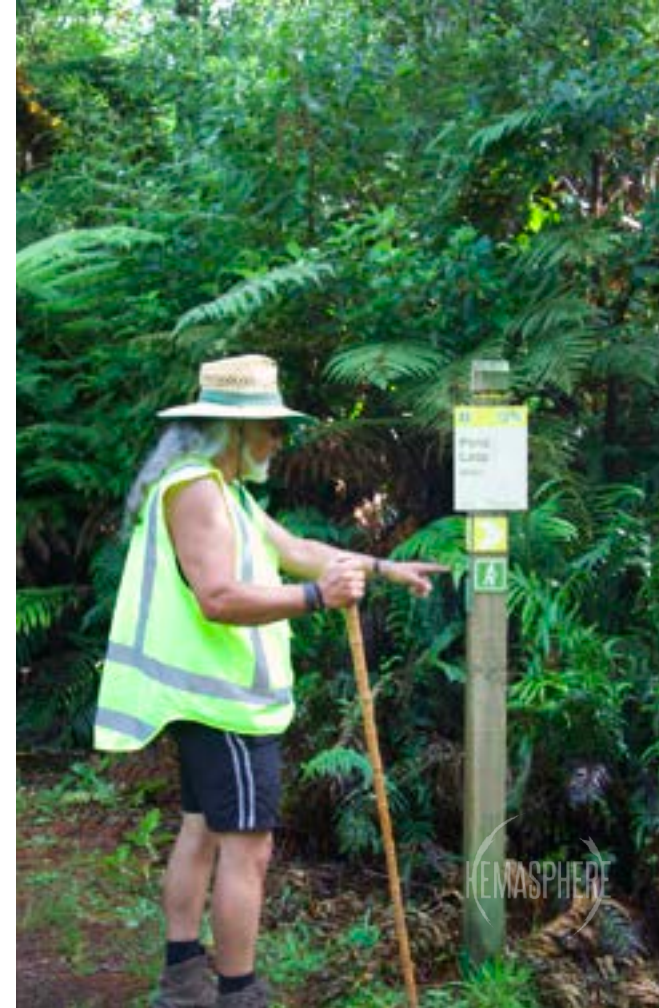
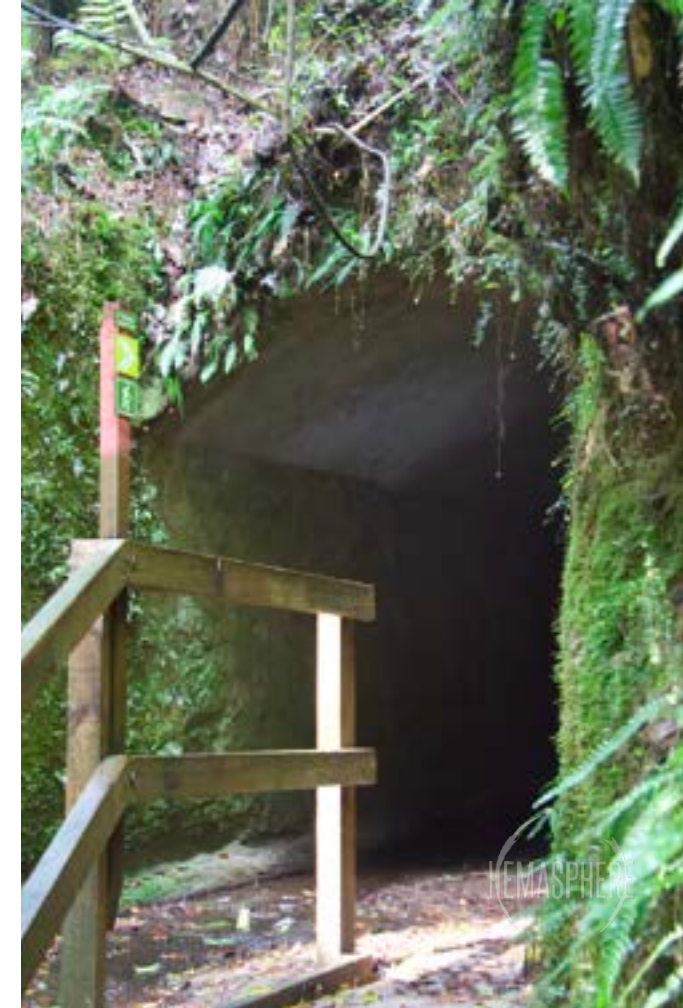
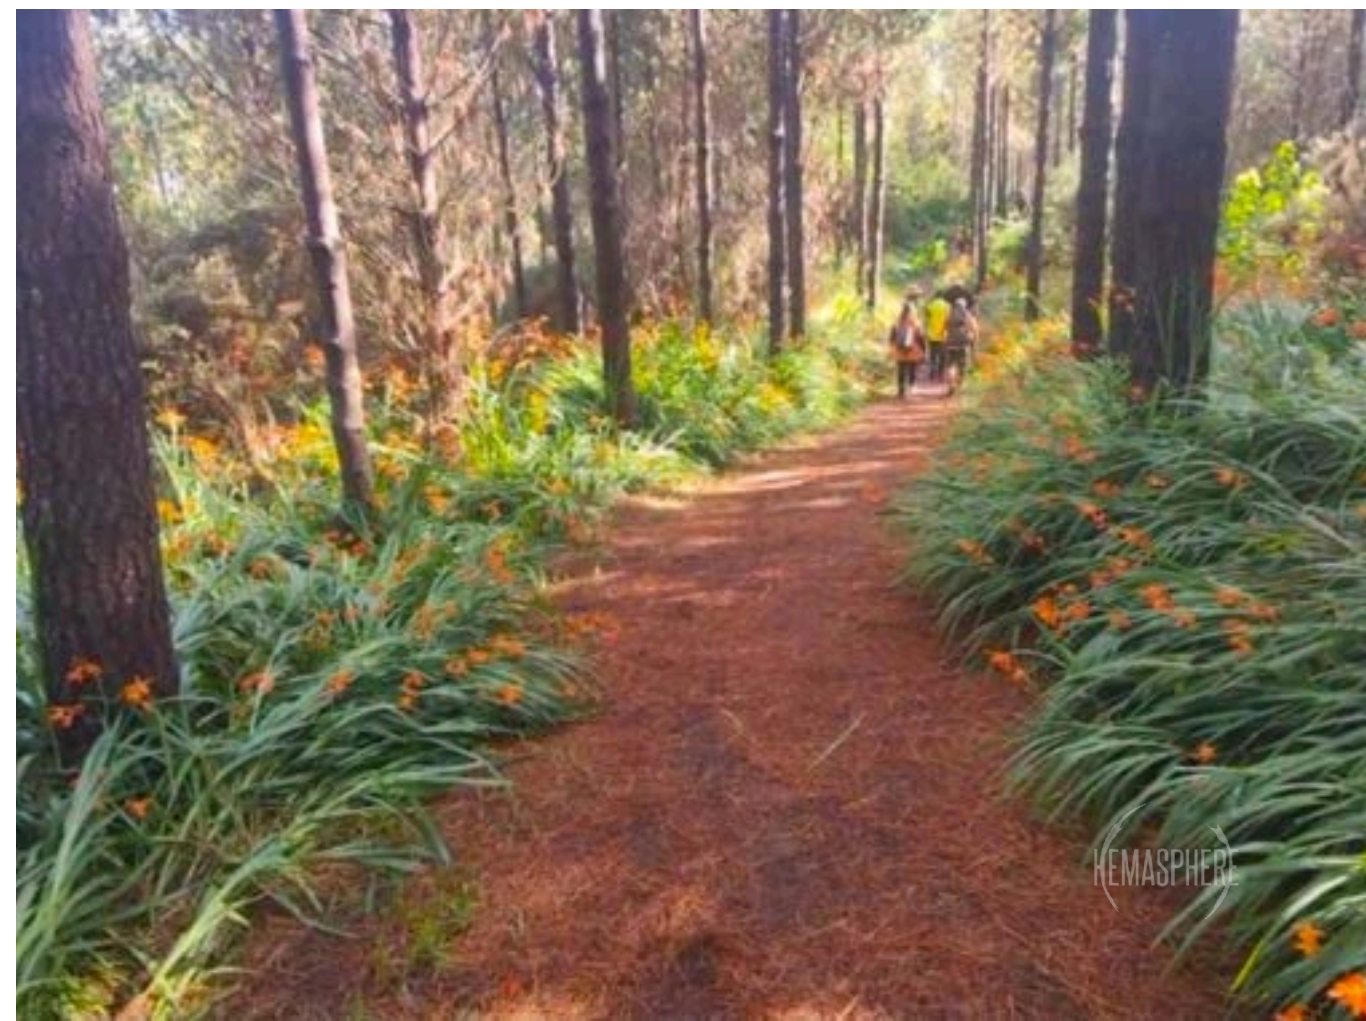
1. Te Rerenga (Site 1)

Access	<ul style="list-style-type: none">• Difficulty: Access to the Te Rerenga isn't easily possible from the existing track network, we did not manage to access the Te Rerenga directly.
Recreational	<ul style="list-style-type: none">• Although access to the Te Rerenga was not achieved, there is huge cultural and recreational potential in the existing track network established by the TECT Park.• Walks and camping.
Environmental	<ul style="list-style-type: none">• Mostly regenerated Rewarewa, and a mix of native and pest plants.• Lots of pest sign including possums, and ungulate damage.• Unhealthy understory.• Dried riverbed no life.
Monitoring	<ul style="list-style-type: none">• Pest monitoring and control required.• Water testing• Catchment management investigation needed.• Observational Monitoring Plots.
Cultural and Historical significance	<p>The area was traditionally known as Te Waitakahī, Taumata, Ngāwaro.</p>

Cultural Recognition Options	<p>Option 1 - Mahi whakairo, carved pou to commemorate an event or tupuna</p> <p>Option 2 - Kohatu to signify points along the journey and key narratives on signboards</p> <p>Option 3 - Signage upgrade to incorporate cultural designs along walkways and camping sites</p> <p>Option 4 - Cultural access ways and infrastructure to areas leading to the awa</p> <p>Option 5 - Procurement opportunities for iwi in maintenance, monitoring, commercial interests and education programmes</p>
------------------------------	--

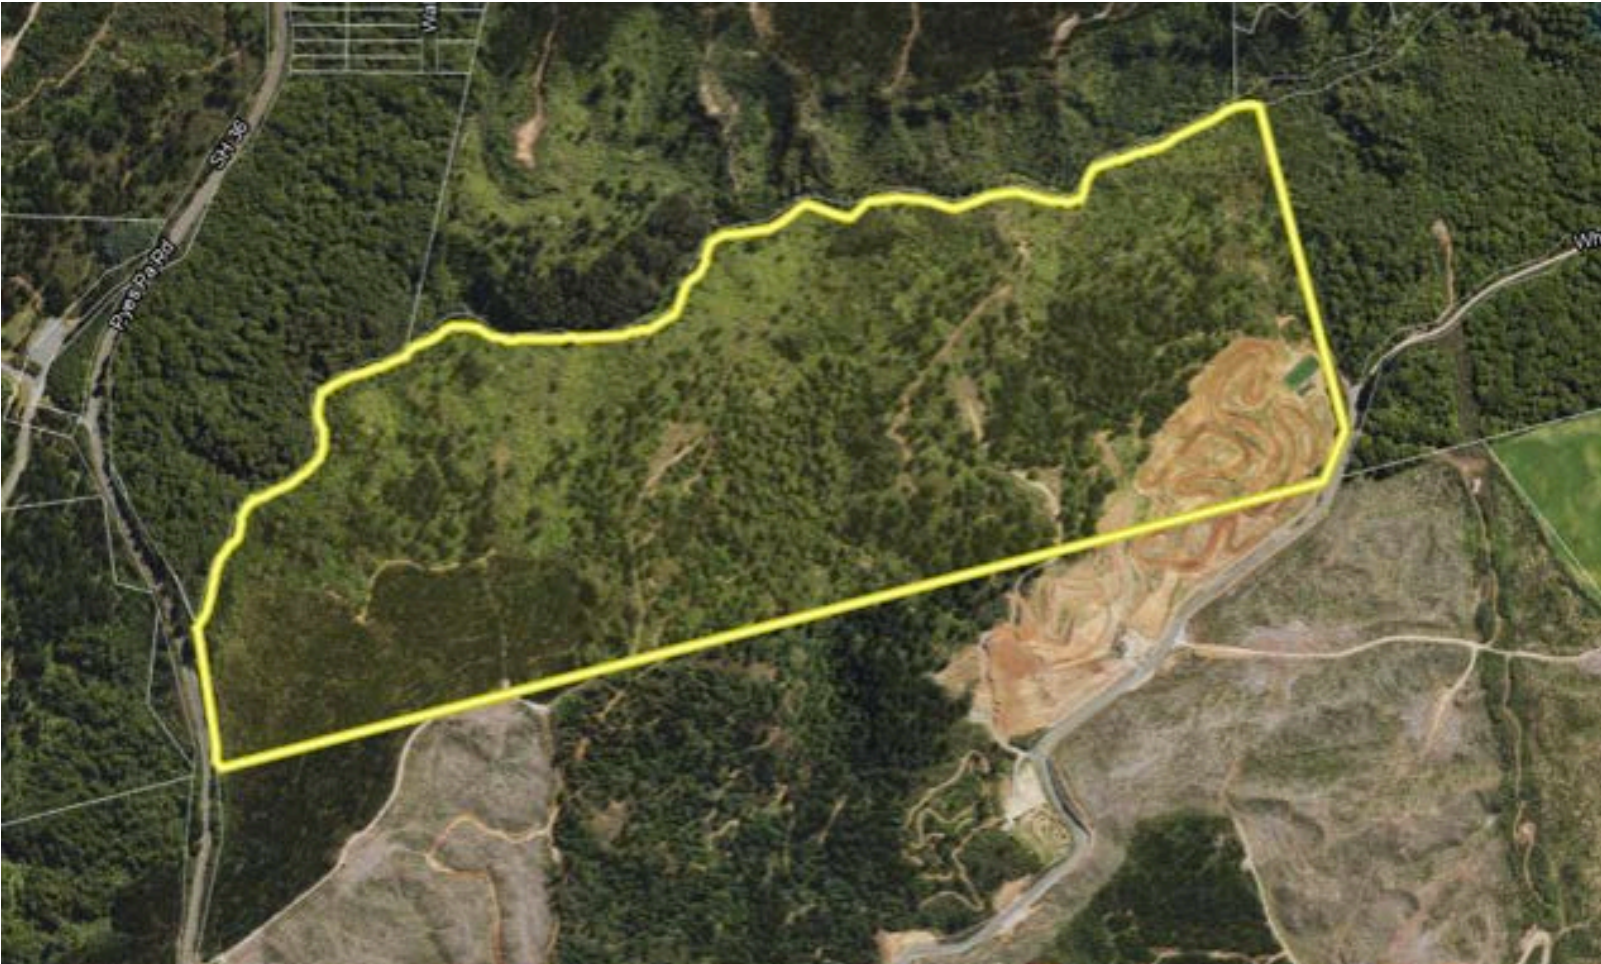
Aerial image of Te Rerenga (Site 1)

- Access for Te Rerenga 1 is through TECT Park using the Te Rerenga Tunnel Loop Track. To create a clear guided track to minimise confusion if we cut and mark the area out for our whanau it will give a better understanding on where they are needing to go. There is potential to establish a new track or redirect the current track for easier access. As we are wanting our whanau to reconnect with the awa thinking about our kaumatua, we want to make the area safer as parts of the track are difficult to access due to the terrain being slippery or steps being uneven or steep.

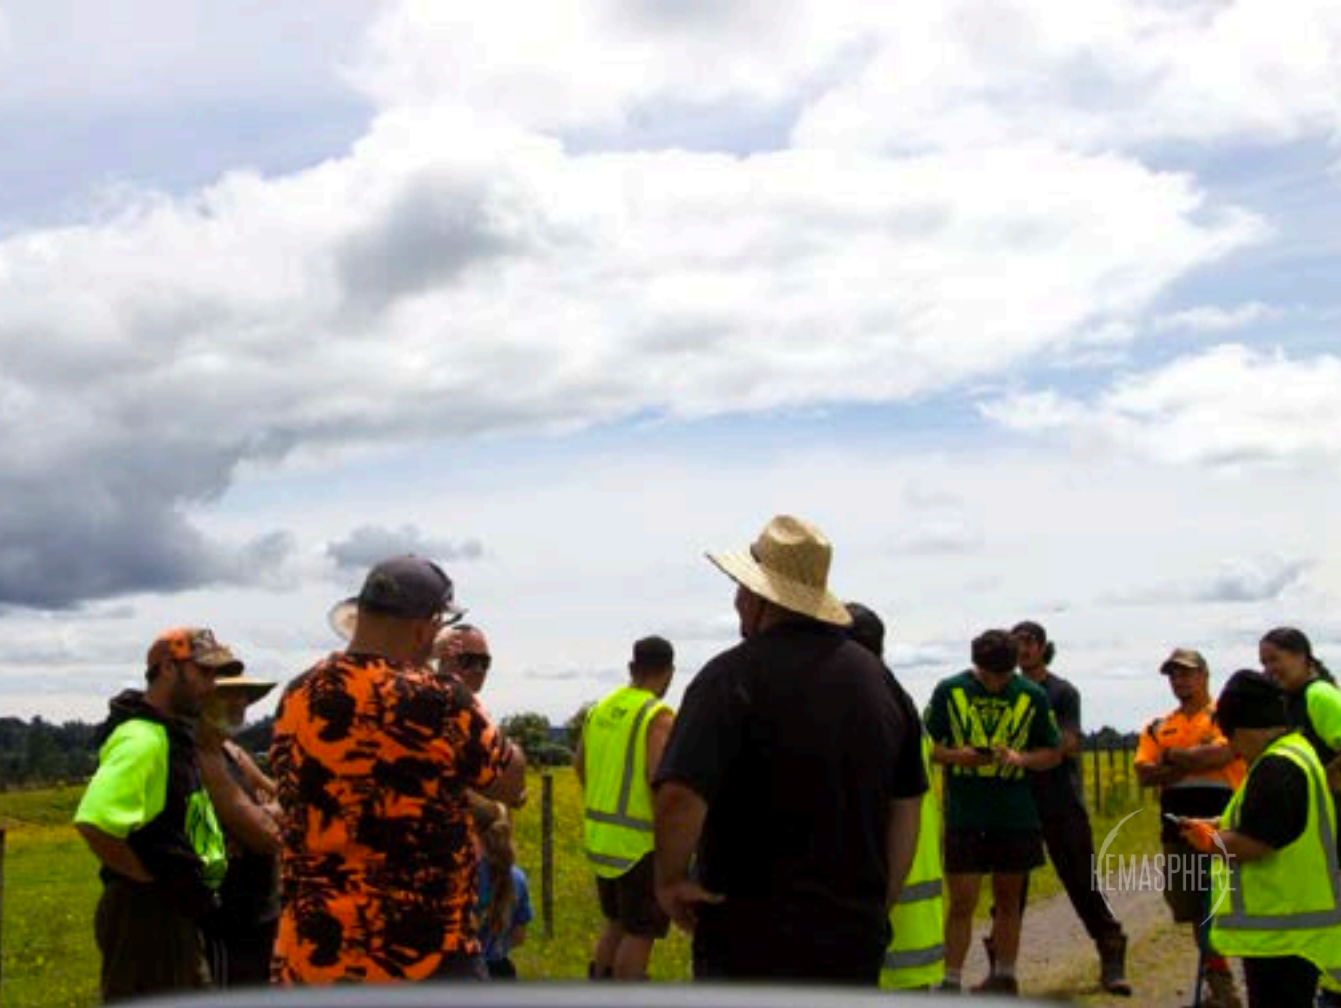
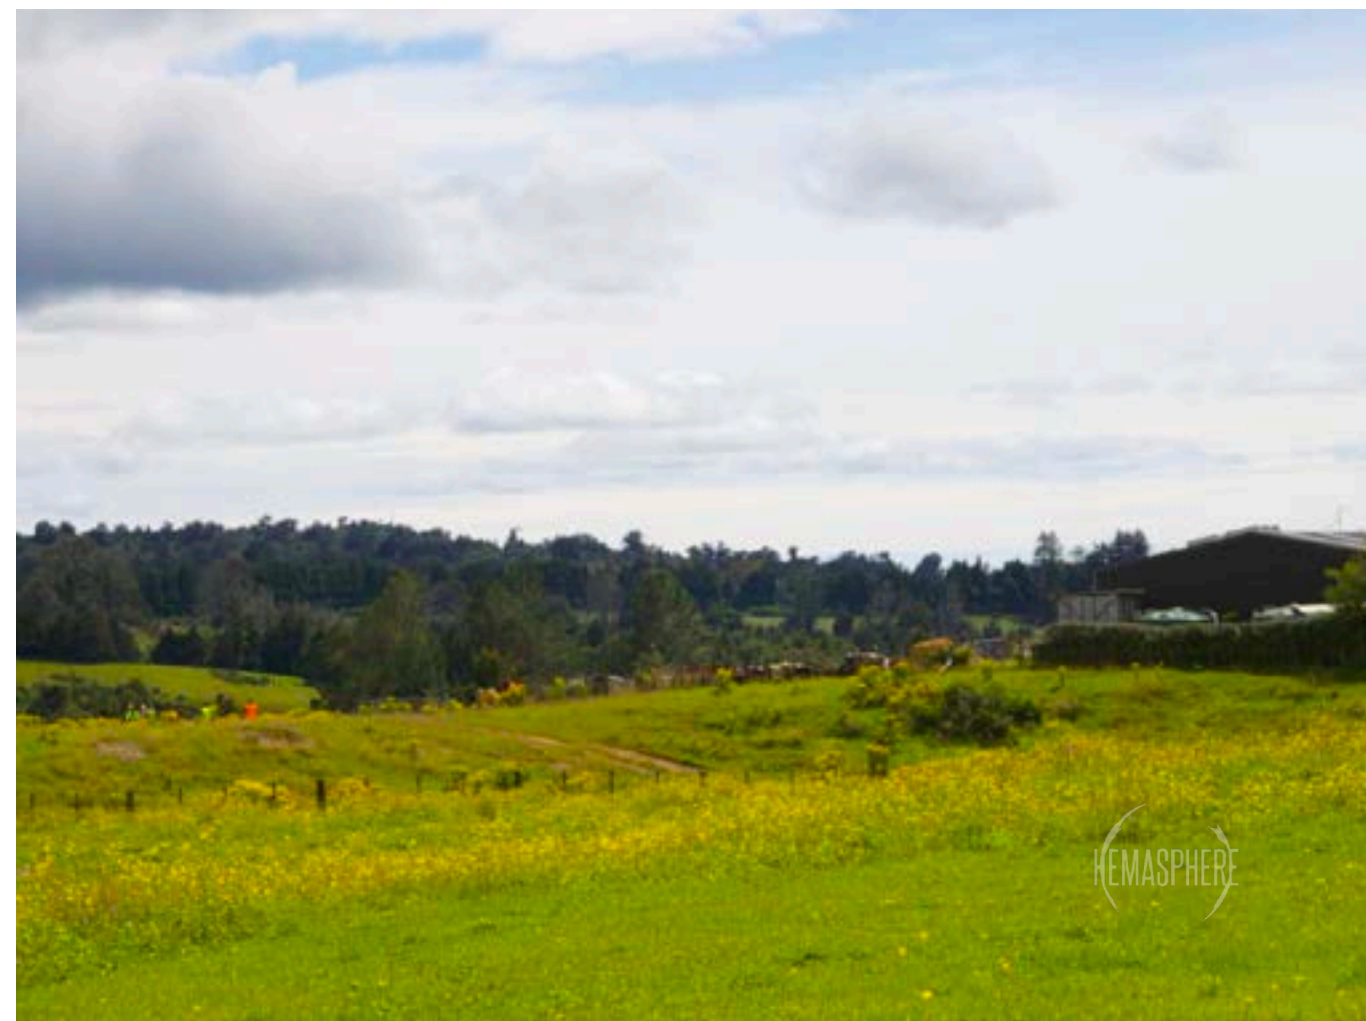
2. Te Rerenga (Site 2)

Access	<ul style="list-style-type: none">• Difficulty: Access is difficult due to the terrain and being landlocked from private blocks.
Recreational	<ul style="list-style-type: none">• Not a lot of recreational potential due to the difficult and unsafe terrain.
Environmental	<ul style="list-style-type: none">• Mostly regenerated Rewarewa, and a mix of native and pest plants.• Lots of pest sign including possums, and ungulate damage.• Dried riverbed no life.•
Monitoring	<ul style="list-style-type: none">• Pest monitoring and control required.• Water testing• Catchment management investigation needed.• Observational Monitoring Plots.
Cultural and Historical significance	<p>The area was traditionally known as Heruiwi, a significant pā site that overlooked the convergence of the Te Rerenga and the Whataroa rivers to create the Waiari.</p>

- The terrain heading down to the awa is not suitable for the average person. It was identified as a difficult, steep and rocky site. Although this was not the original area, we wanted to view this was a starting point. If we cannot gain access through both landowners, we have started a relationship with Steve and hope to continue this relationship. If this is going to be used as an entrance point to the site, there will need to be clear tracks cut with ropes being installed to create a safer hike up and down the ridge line.

- Once the boys had reached the bottom of the ridge to where the awa should be flowing through they identified it to be bone dry. The old riverbeds are dried out and dusty which shows there have been no signs of flowing water through there in years.

Cultural Recognition Options	<p>Option 1 - Mahi whakairo, carved pou to commemorate an event or tupuna</p> <p>Option 2 - Kohatu to signify points along the journey and key narratives on signboards</p> <p>Option 3 - Signage upgrade to incorporate cultural designs along walkways and camping sites</p> <p>Option 4 - Procurement opportunities for iwi in maintenance, monitoring, commercial interests and education programmes</p>
------------------------------	--

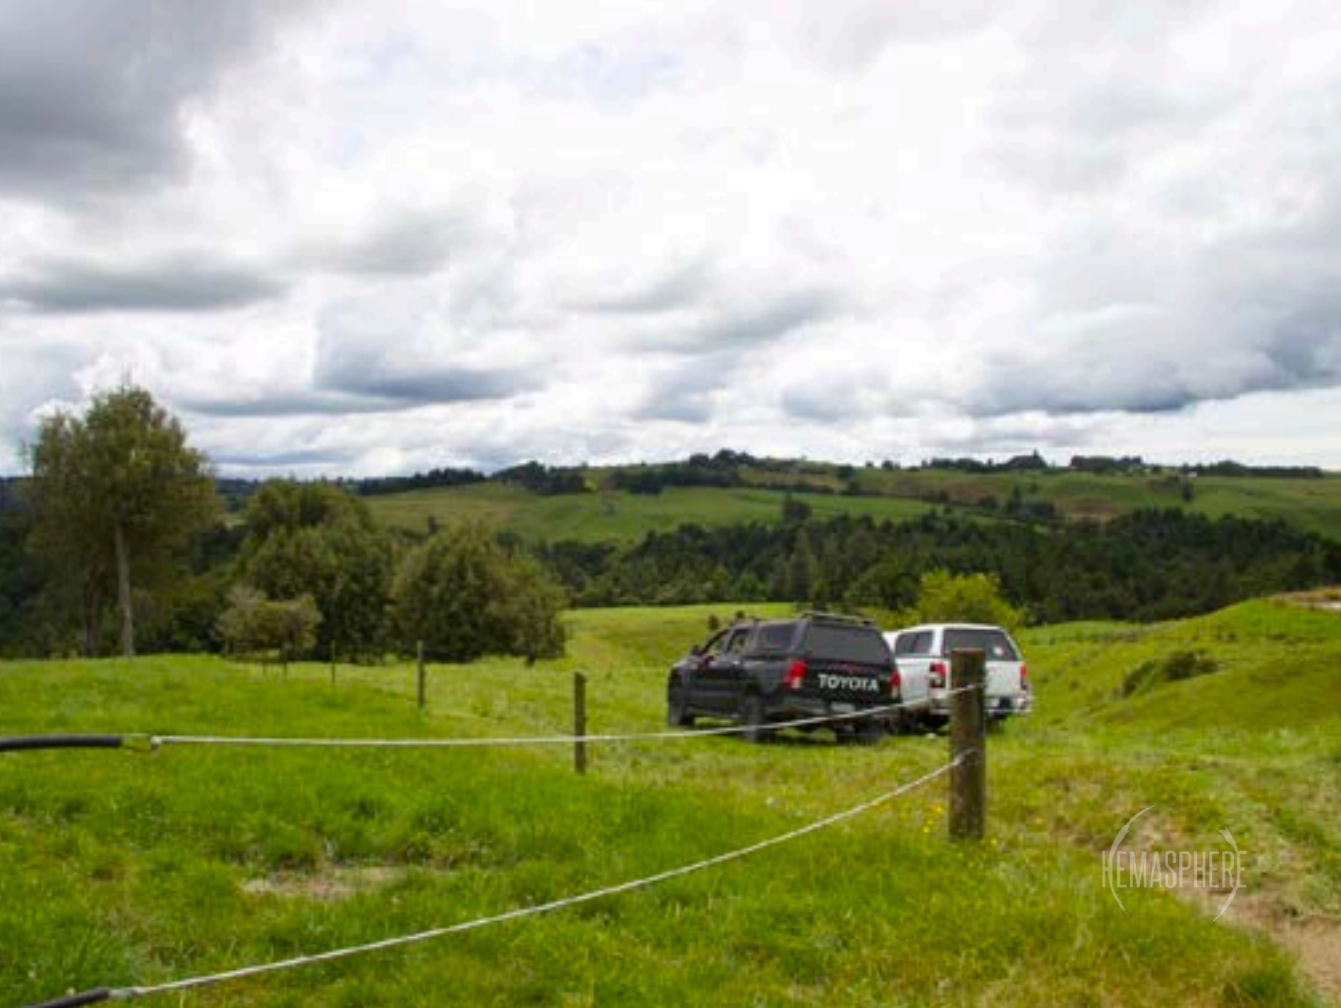
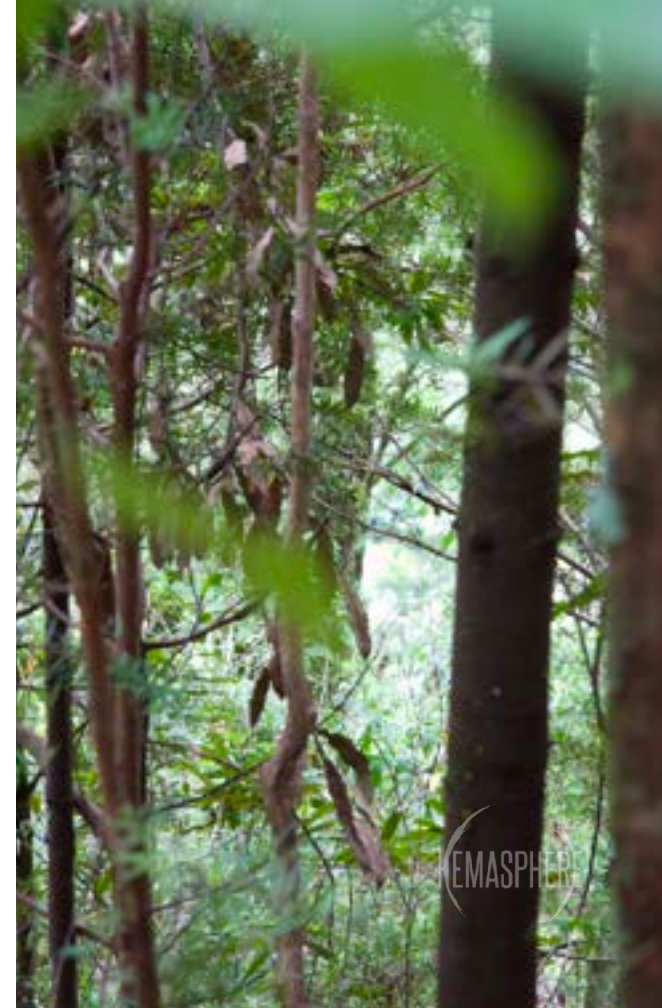
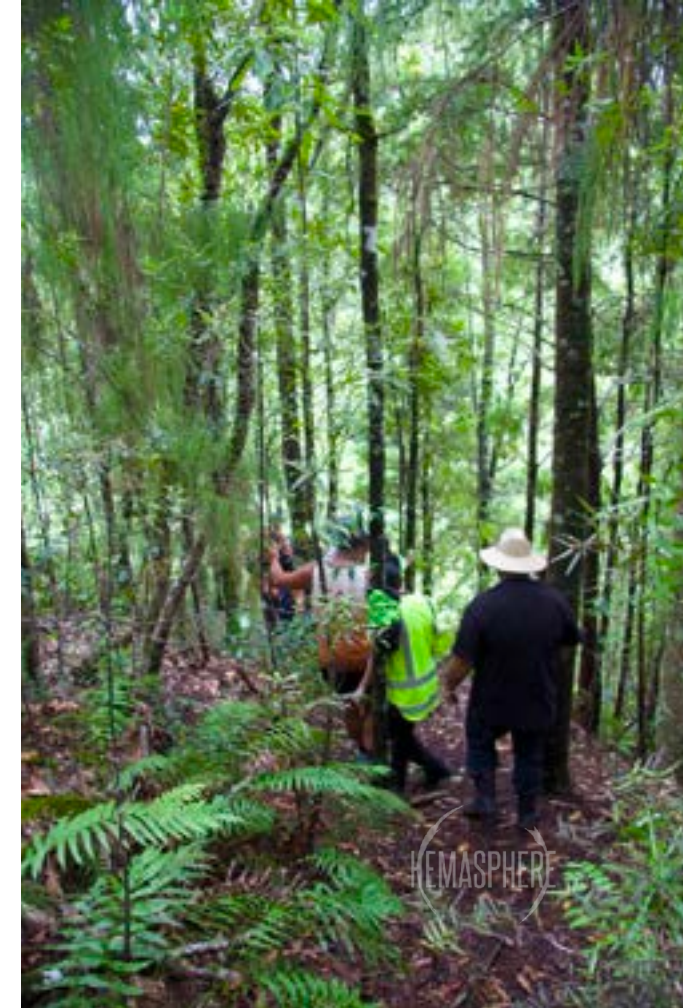
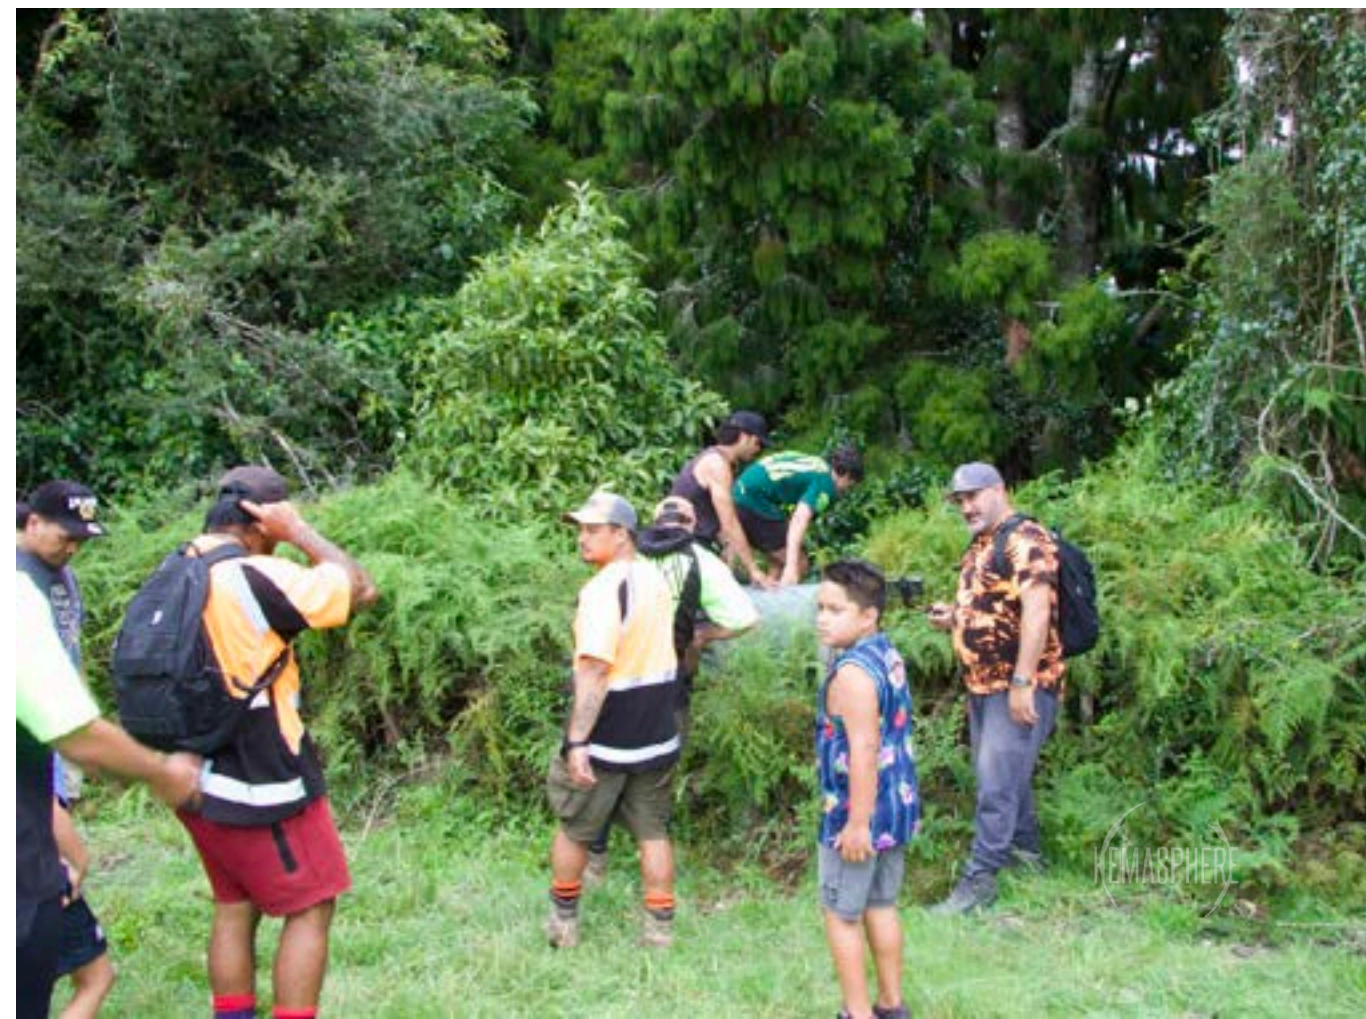
3. Te Ranga ō Hineata

- Difficulty: Access is difficult due to the steep terrain and being landlocked from private blocks, Access for monitoring purposes a priority, some access agreements with land owners and light infrastructure required to make it safe.

- Farmland with small 20 – 50 meter riparian buffer of native mostly naturally regenerated, includes a lot of Tōtara and Rewarewa.
- Lots of pest sign including possums, and ungulate damage.
- Healthy river below.
-

- Water species monitoring including Koura, tuna and water invertebrates.
- Water testing
- Observational Monitoring Plots.
- Steady source of water from the Mangatoī tributary, water appears very clean.

- It was identified the track down is steep and slippery but with clear marking, cutting and a few small infrastructure items put in place it will help getting to the bottom of the cliff. This site will be a great monitoring spot however with access through private property and how the terrain is formed it is not ideal for recreational purposes.

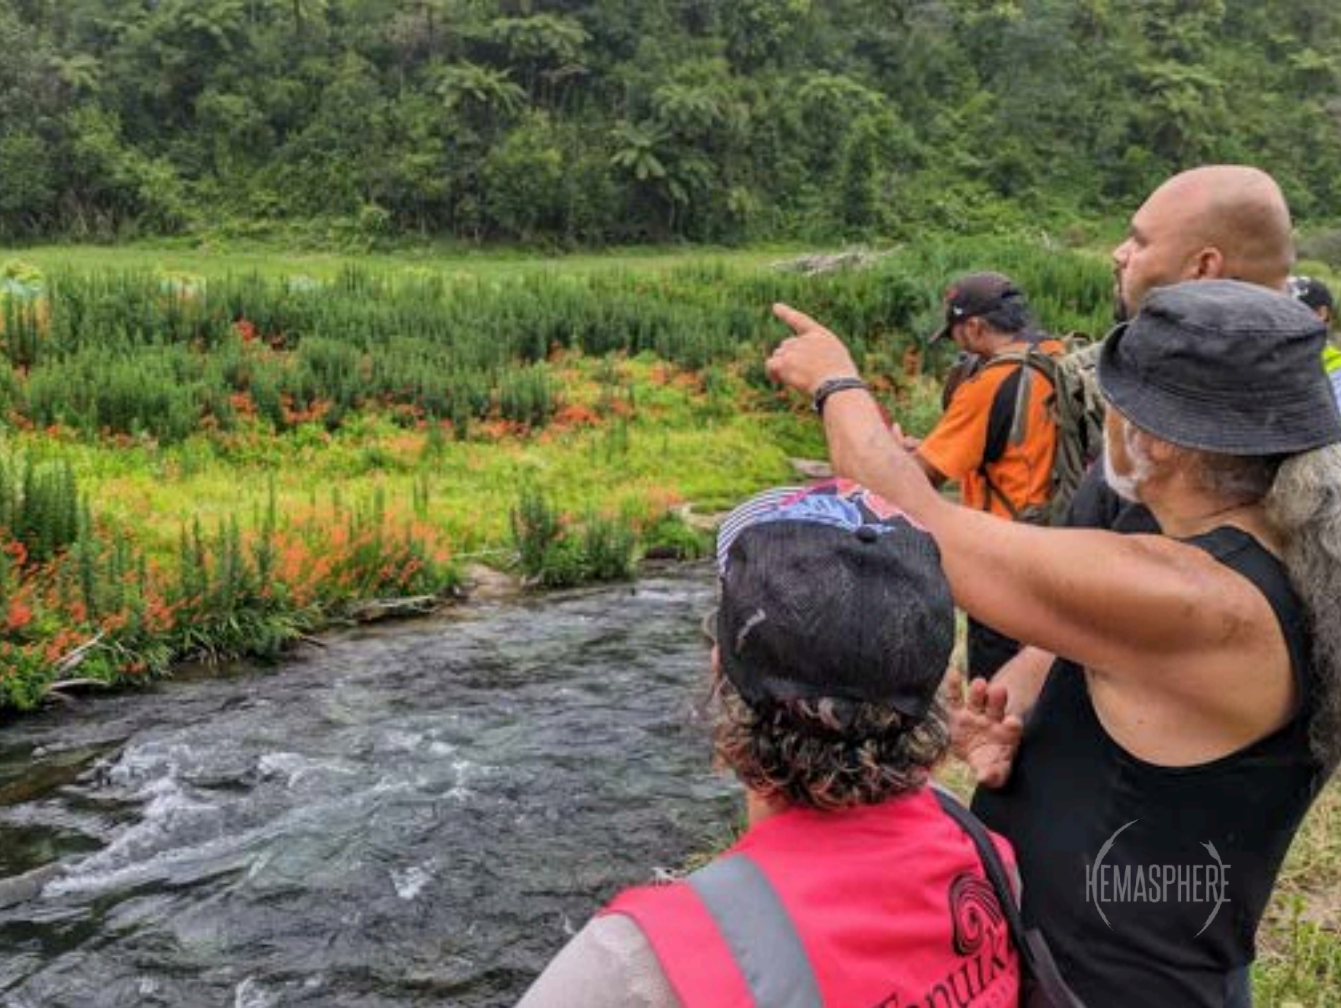
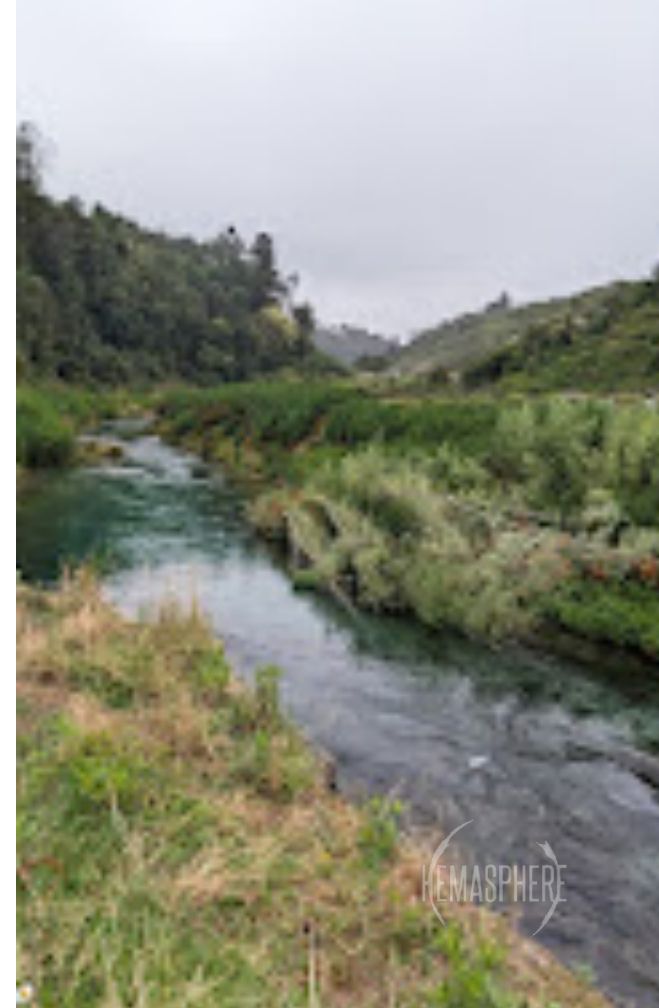
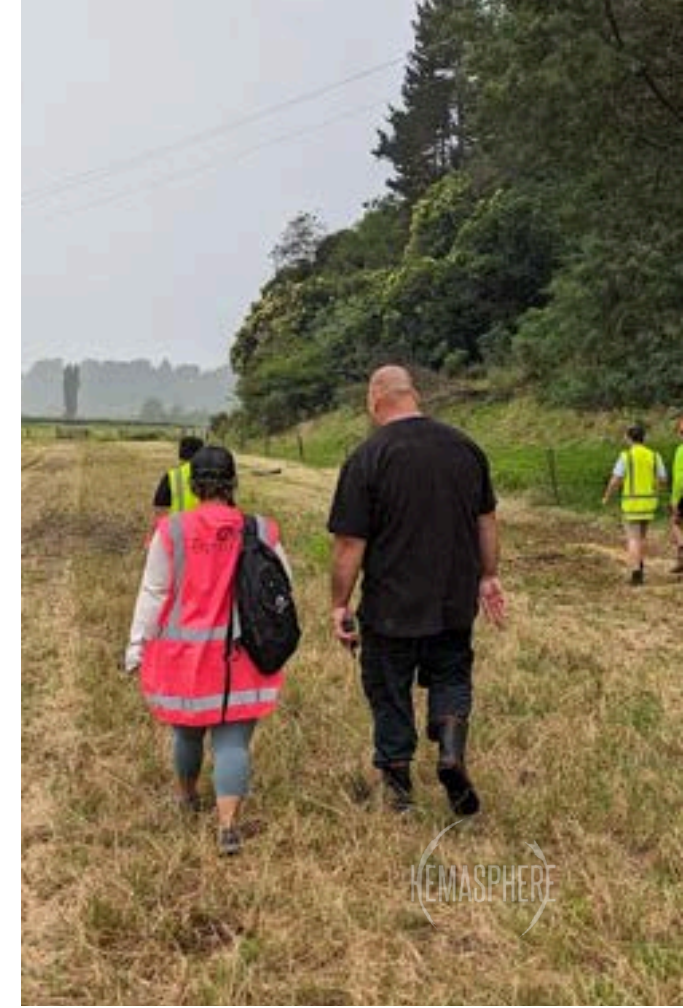
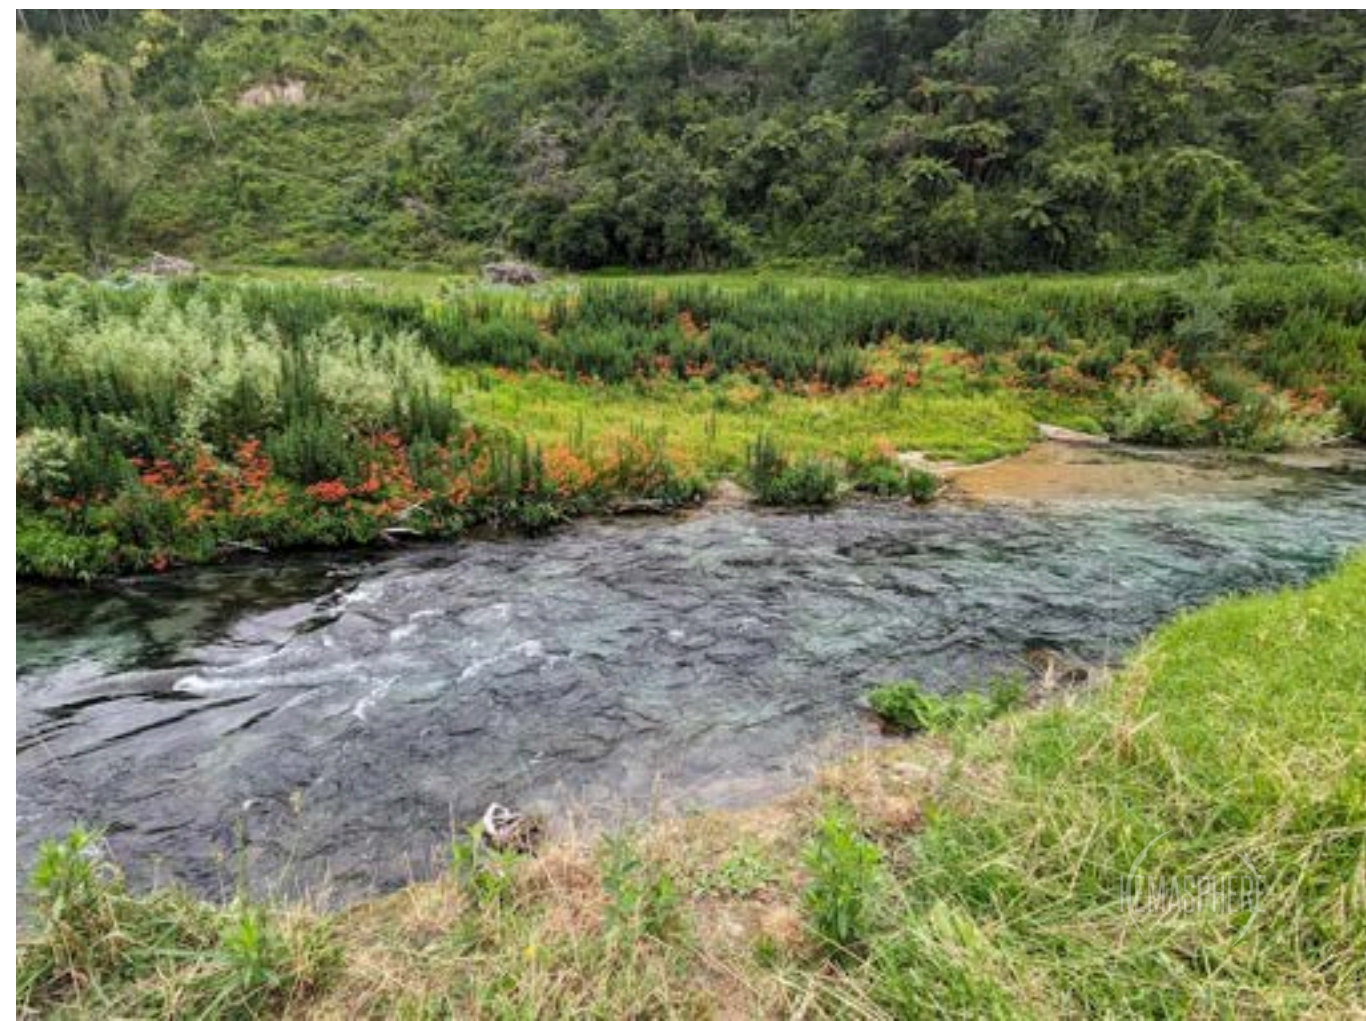
4. Pōtakataka

- Difficulty: Safe access quite easy, low land farming and orchard land, some permission agreements required with landowners.

- Low lying farms and orchards.
- Lots of weeds on the river margin.
- Lots of erosion.
- Shallow wide river points.

- Water species monitoring including Koura, tuna and water invertebrates.
- Water testing.
- Observational Monitoring Plots.
- Very full water appears clean, slightly murky, needs monitoring.

- Although we didn't make it to the point we were wanting to go, looking over the site we were able to identify a few different things that will need to be done. Pest plant control will need to happen as it is very noticeable, there are multiple different weeds present along the margins in full force. If we are looking into removing the pest plant species, we will need to do riparian planting as it was very noticeable the pest species are what is holding the banks together.

- The site itself is accessible and we don't necessarily need to cut tracks. By using paddle-boards, we can use the awa to get to the site as an option but, if we build a relationship with the orchard owner this site will be even easier to access.

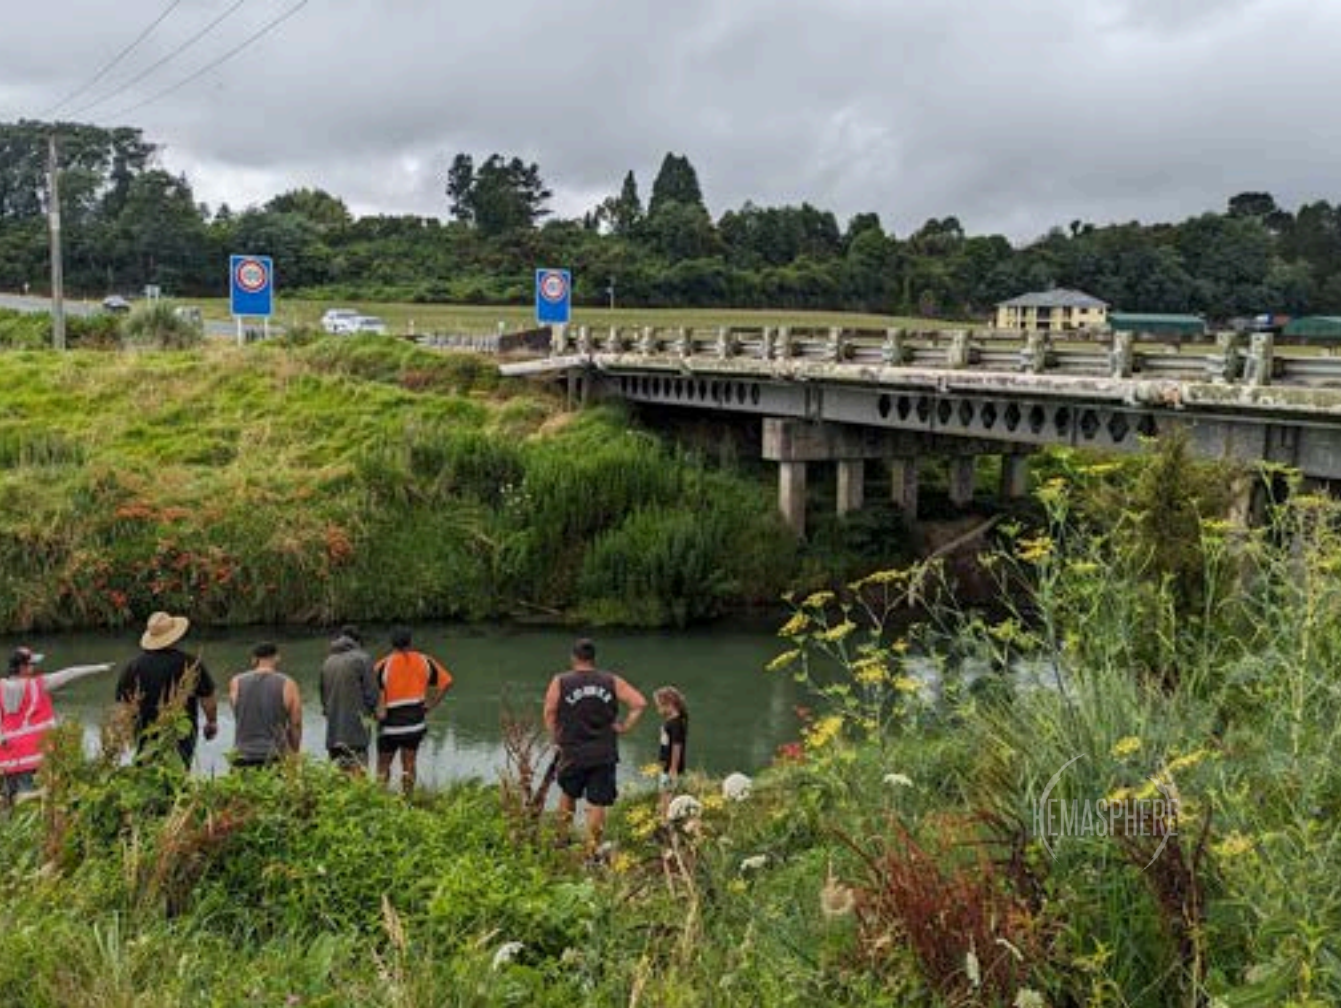
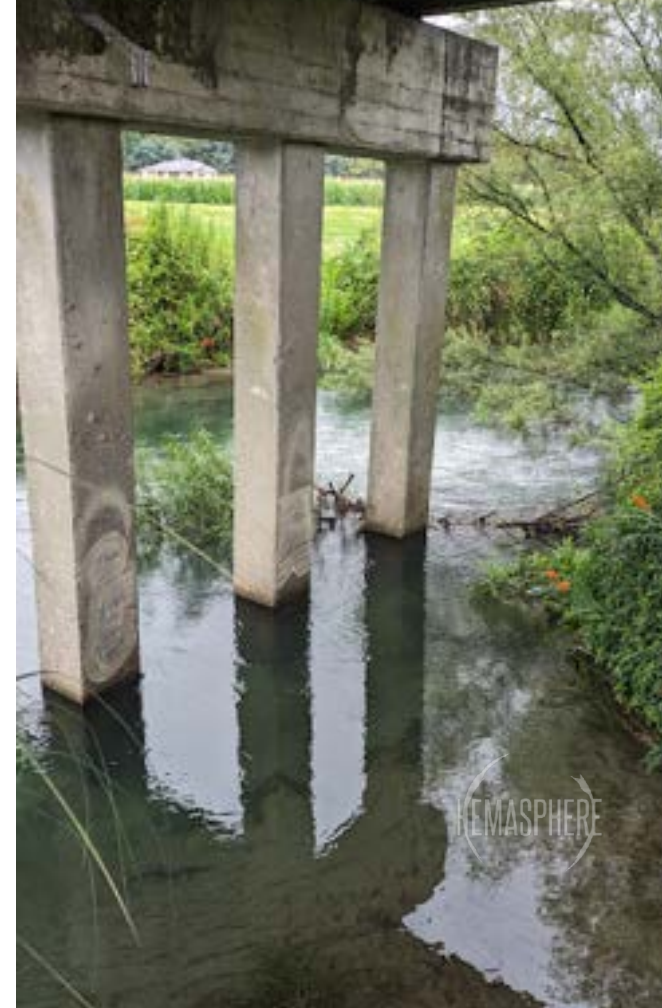
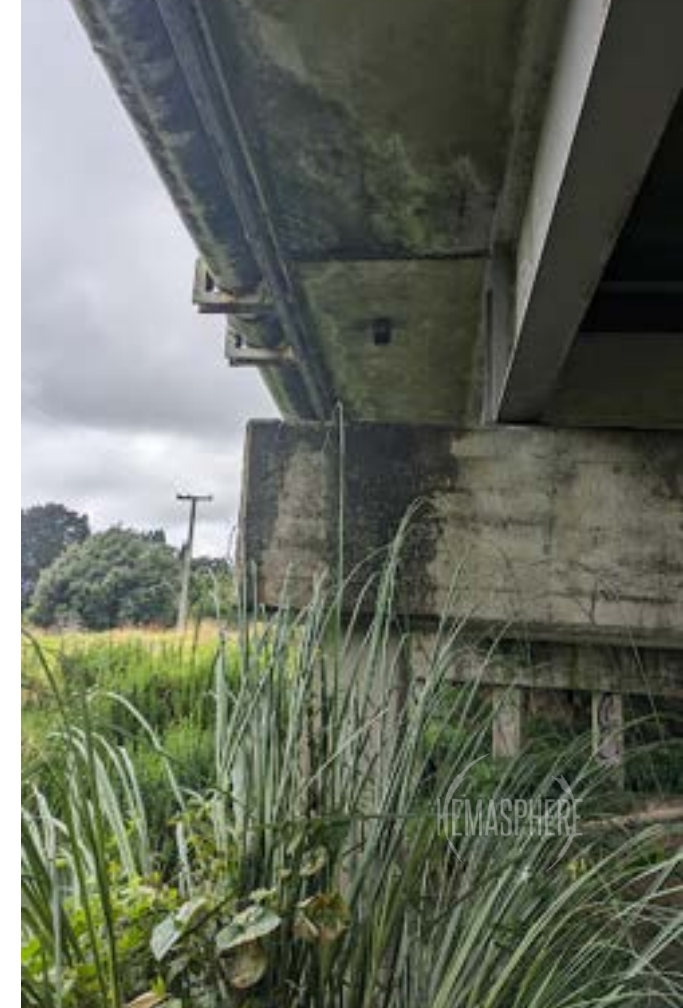
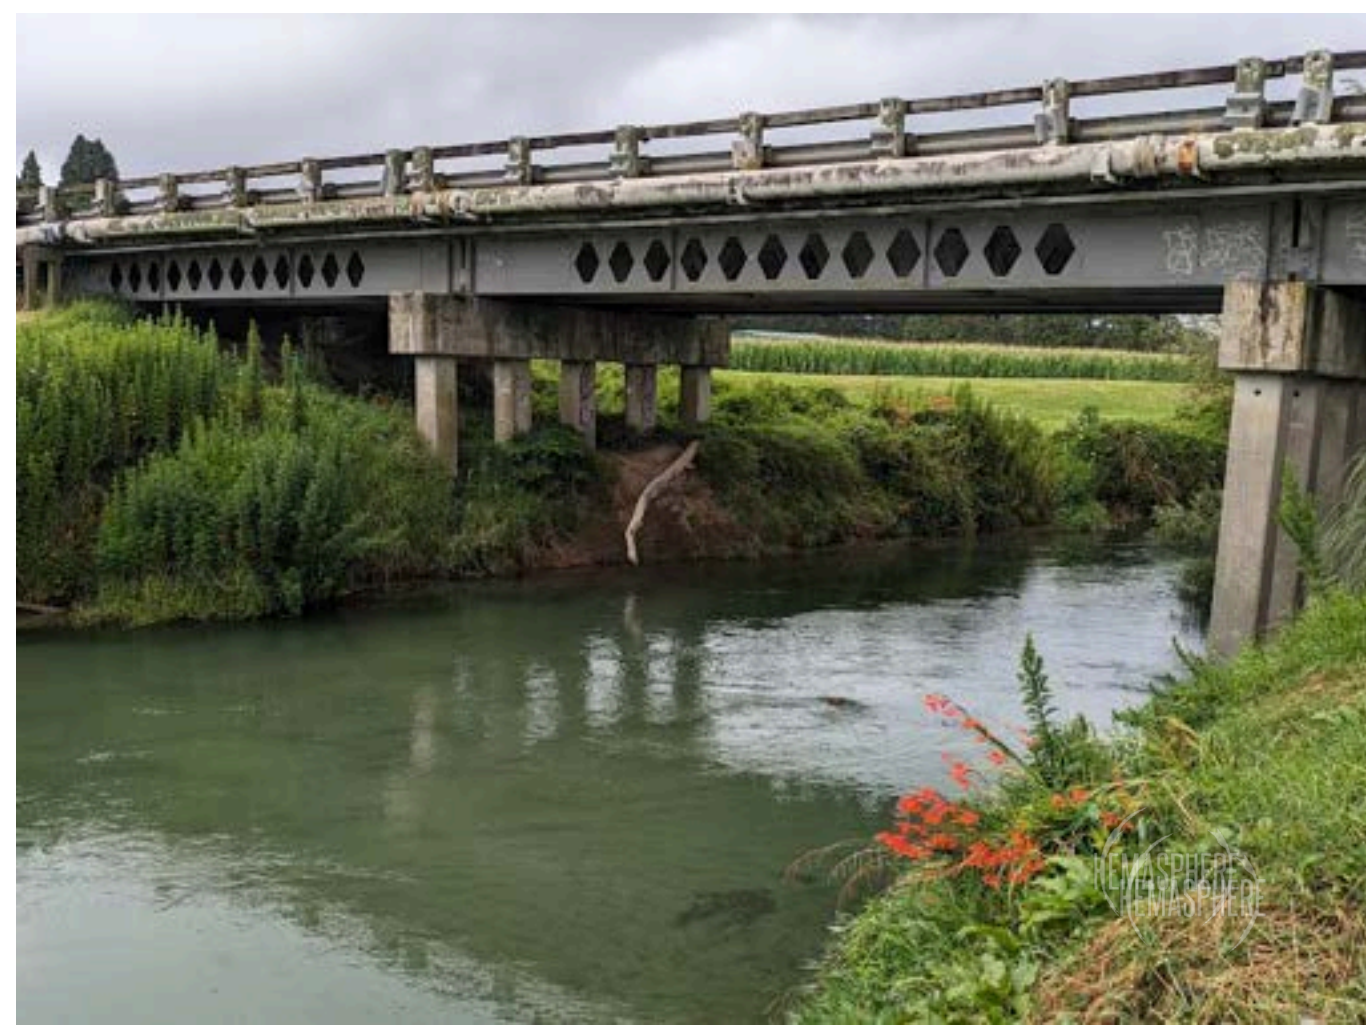
6. Waiari Bridge

- This area holds a lot of memories for whanau as there have been generations on generations swimming in this area. Being close to the Makahae marae this is an active swimming hole for tamariki to go and swim, however we have noticed it is very unsafe to access as you are needing to cross the road which is one of the busiest roads in Te Puke.

- We have identified a couple of ways we can make this site safer and easily accessible from the marae by building a light infrastructure underneath the bridge so tamariki can cross under safely, but we can incorporate this into being a jumping platform for recreational use.
