Waiari Kaitiaki Advisory Group

CULTURAL RECOGNITION

SITE VISIT JANUARY 2024

PRELIMINARY REPORT

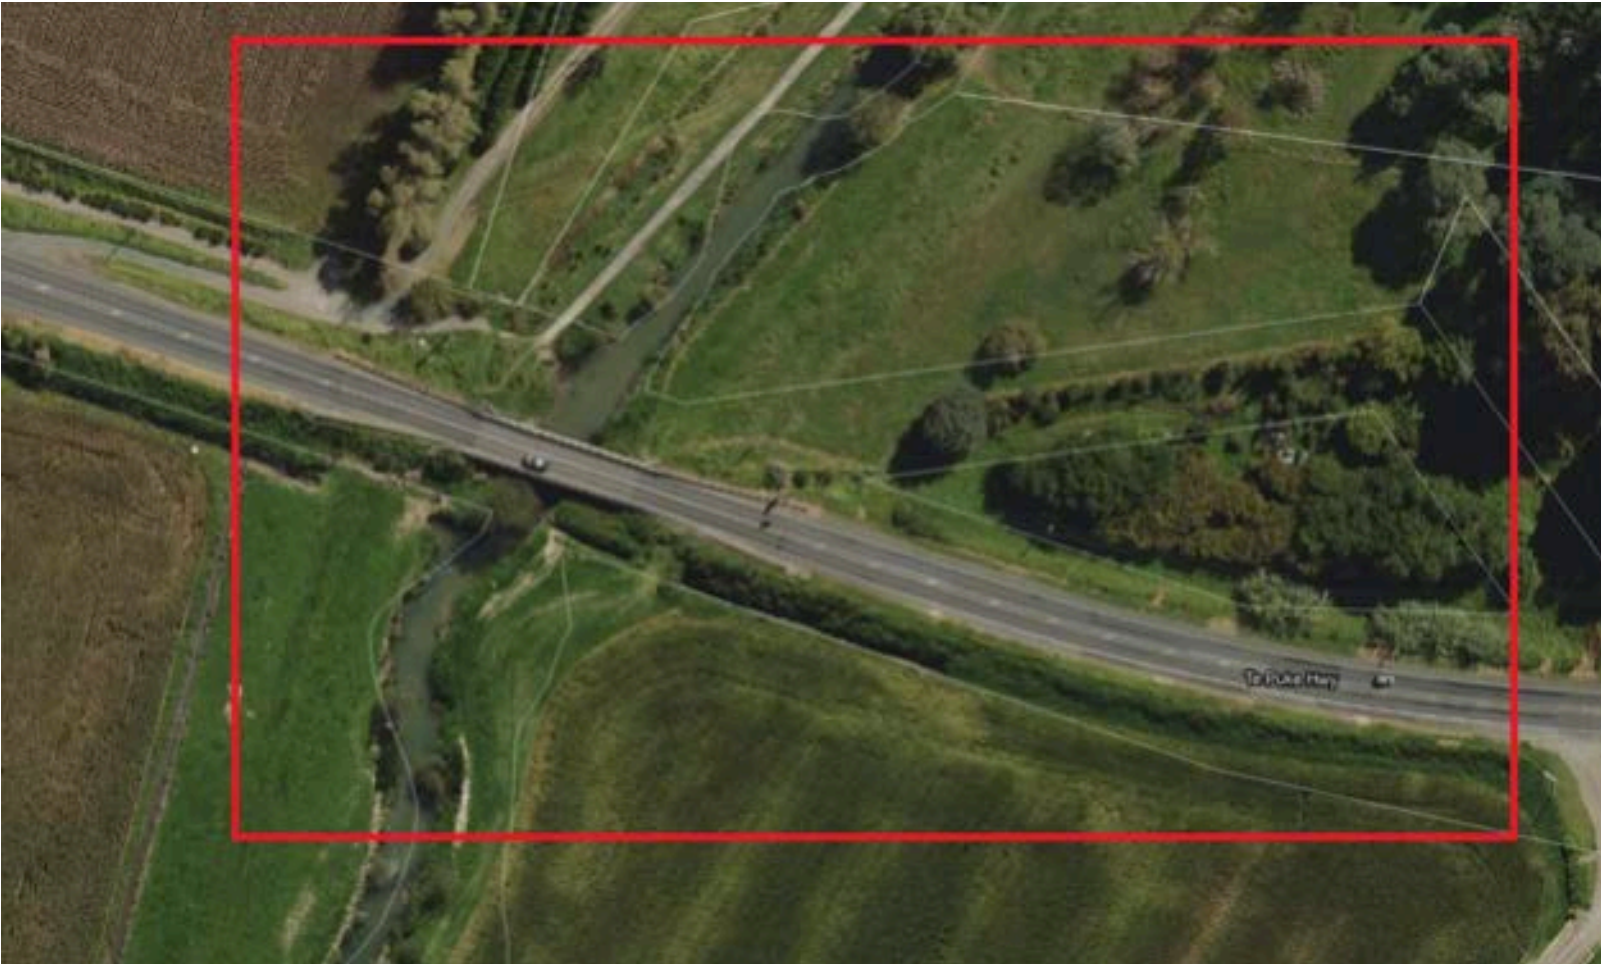
Aerial image of Waiari Bridge Site

- Access is easy via the Te Ara Kahikatea track or via roadside, however quite dangerous especially for kids given the proximity to the highway.
- Recreational

- Current well used swimming site can be dangerous due to the road.
 - Camping site and kai site.
- Environmental

- Lots of public walkers on nearby track.
 - Stormwater discharge.
 - River edge is quite eroded due to swimming and lack of riparian vegetation.
 - River is very shallow at this point.
 -
- Monitoring

- While visiting the site it was clear to see species present floating around in the pools near the edge of the banks. We didn't identify the area to be overly populated with pest plants compared to upstream, but it could do with some riparian planting to maintain the upkeep of the banks. This is a site where we will be able to monitor water quality, species, flora and fauna.

- We have identified a couple of ways we can make this site safer and easily accessible from the marae by building a light infrastructure underneath the bridge so tamariki can cross under safely, but we can incorporate this into being a jumping platform for recreational use.

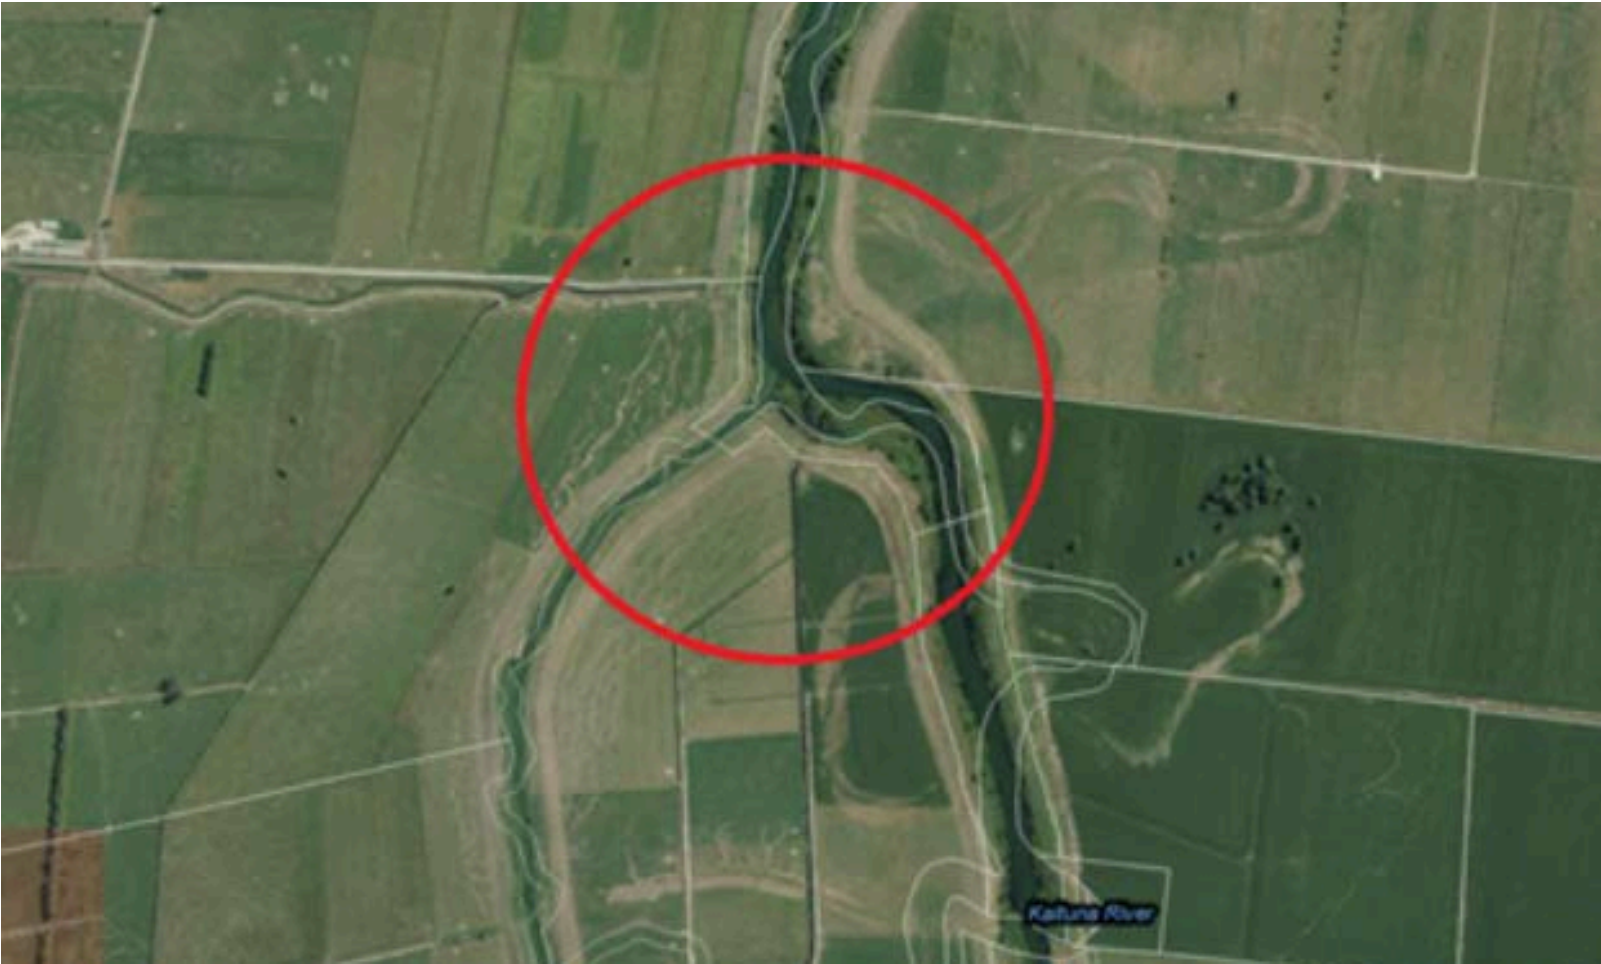
Aerial image of Kongutu ki te Kaituna Site

- Difficulty: Access is easy via the wastewater treatment plant, although it is quite a walk it can be driven.

- All farmlands, river heavily stop banked.
- Wastewater treatment discharge.
- No riparian natives but instead lots of weed including Willow.
- Pretty poor quality water comparative from the top end, just as a visual observation.

- This area is accessible for an average walker. Accessing this site, you will need to jump a few fences when walking down however, it does connect to the Kahikatea loop track. Once arriving we were able to view different access points where there will be the potential to create relationships with the surrounding landowners so we can use their roads for vehicle access. This is an area where it is more than ideal to monitor for water quality, species, and flora/fauna. Scanning over the area this is where the Waiari meets with Parawhenuamea Stream before heading into Kaituna creating a triangle.

- This area could do with some serious riparian planting as it was noticeable there has been stock along the stop bank and this will help towards filtering any runoff before it reaches the awa. With riparian planting this will also help stabilise the banks and create shade over the awa for any species present. This will also help to keep weeds and pest plants at bay.
