**Ordinary Council meeting
Separate Attachments 1**

11.2	Memorial Park Aquatic Centre update	
Attachment 2	Memorial Park Alternate Site Study - AppD - Scheme Plans (HDT).....	4
Attachment 3	Memorial Park Alternate Site Study - Geo Summary Letter (ENGEO) - Appendix A#2	6
Attachment 4	Memorial Park Alternate Site Study - Topographic Plans (SurveyWorx) Appendix C#2	84
Attachment 5	Memorial Park Alternate Site Study August 2025	90
Attachment 6	Memorial Park Aquatic Facility Feasibility Report Appendix B	107
Attachment 7	Memorial Park Facility Feasibility Report Services Plan Appendix B1#2.	132
Attachment 8	SUMMARY PROJECT RISK REGISTER - Memorial Park Aquatic Centre	133

Geotechnical Summary Letter – Memorial Park, Devonport Road, Tauranga 3110

(Our Reference: 28836.000.001_01)

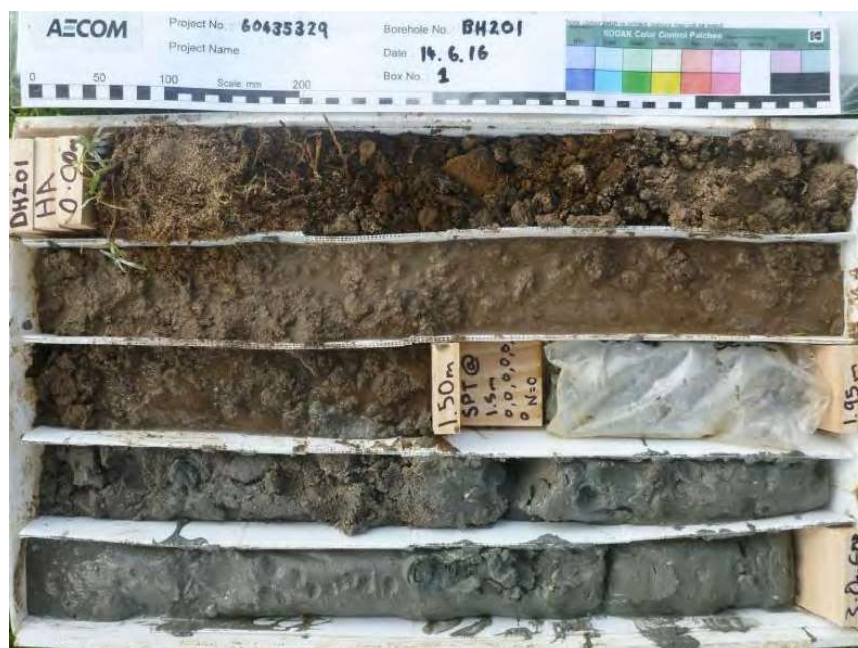
HOLE
IDENTIFICATION**BH201**

**Box: 1 of 15 - Depth: 0.00m to 3.00m of 49.90m**

Date Drilled 14/06/2016 to 16/06/2016

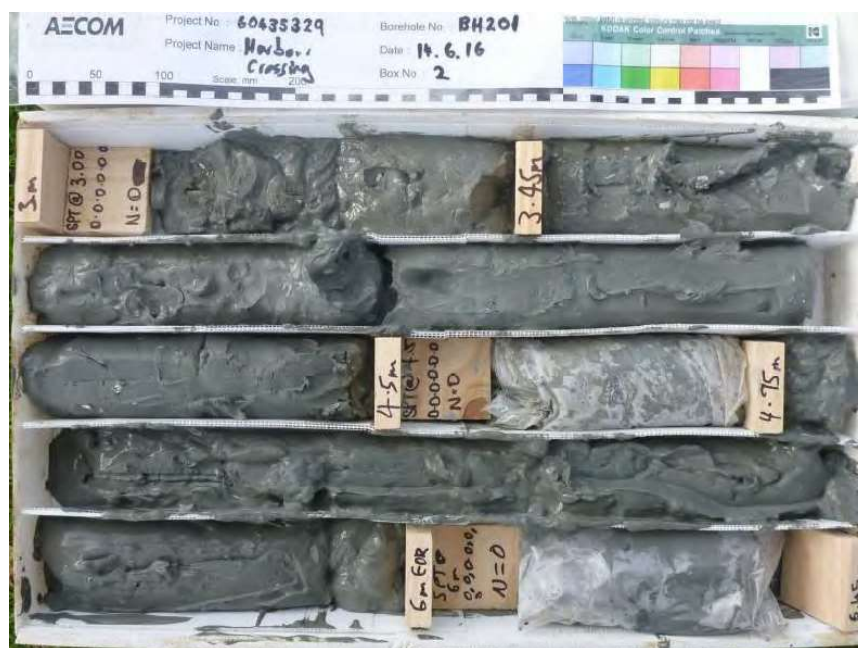
**Box: 2 of 15 - Depth: 3.00m to 6.45m of 49.90m**

Date Drilled 14/06/2016 to 16/06/2016

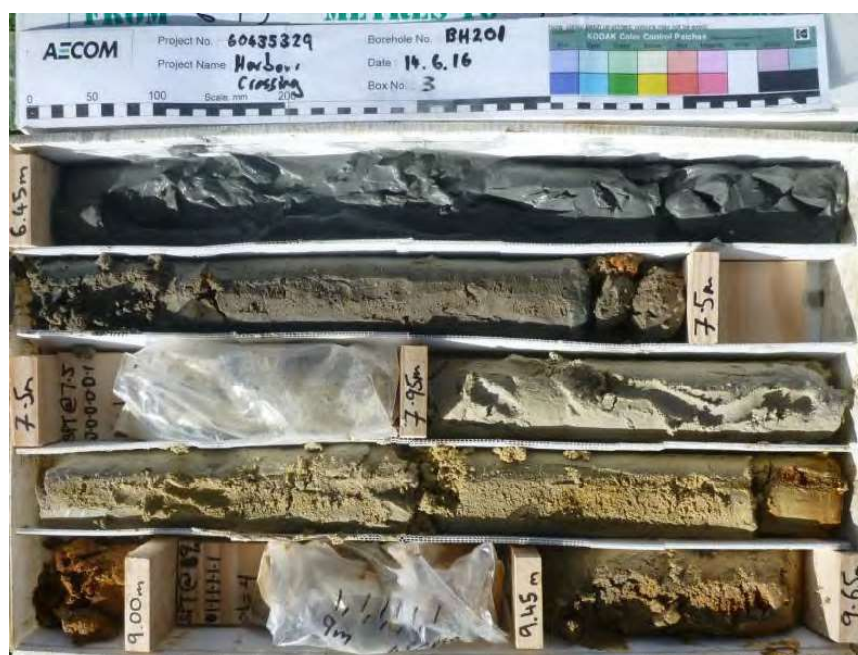
HOLE
IDENTIFICATION**BH201**

**Box: 3 of 15 - Depth: 6.45m to 9.65m of 49.90m**

Date Drilled 14/06/2016 to 16/06/2016

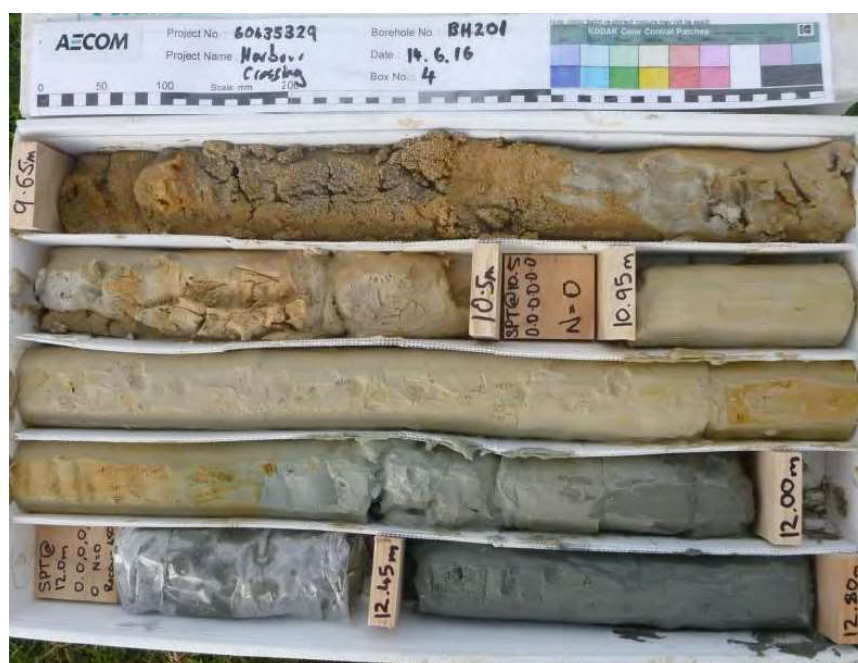
**Box: 4 of 15 - Depth: 9.65m to 12.80m of 49.90m**

Date Drilled 14/06/2016 to 16/06/2016

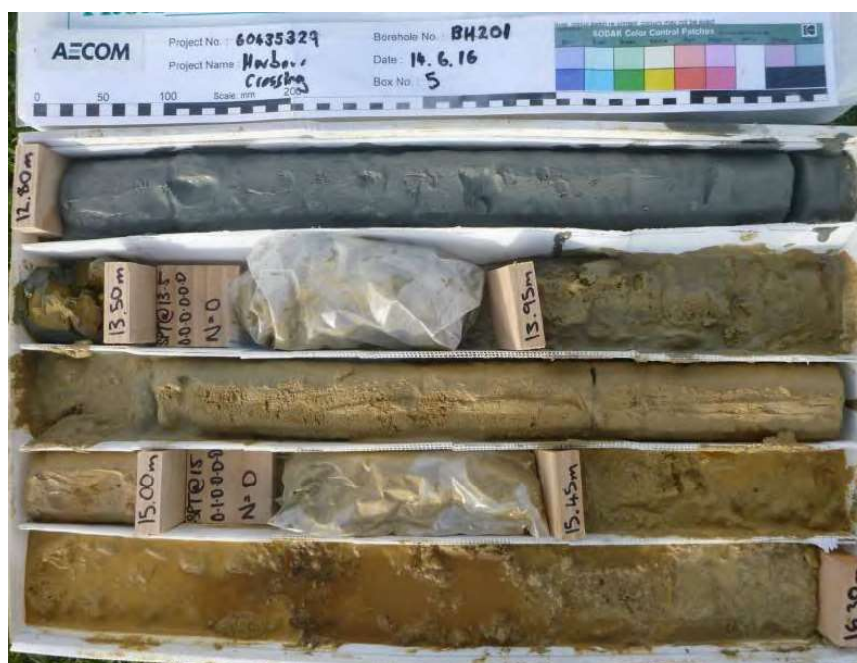
**Box: 5 of 15 - Depth: 12.80m to 16.30m of 49.90m**

HOLE
IDENTIFICATION**BH201**

Date Drilled 14/06/2016 to 16/06/2016

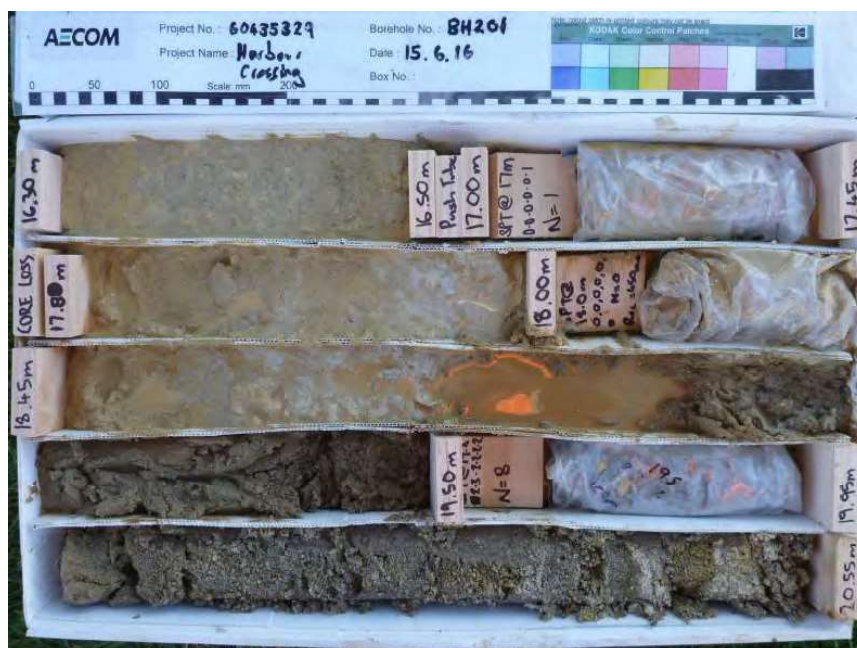
**Box: 6 of 15 - Depth: 16.30m to 20.55m of 49.90m**

Date Drilled 14/06/2016 to 16/06/2016

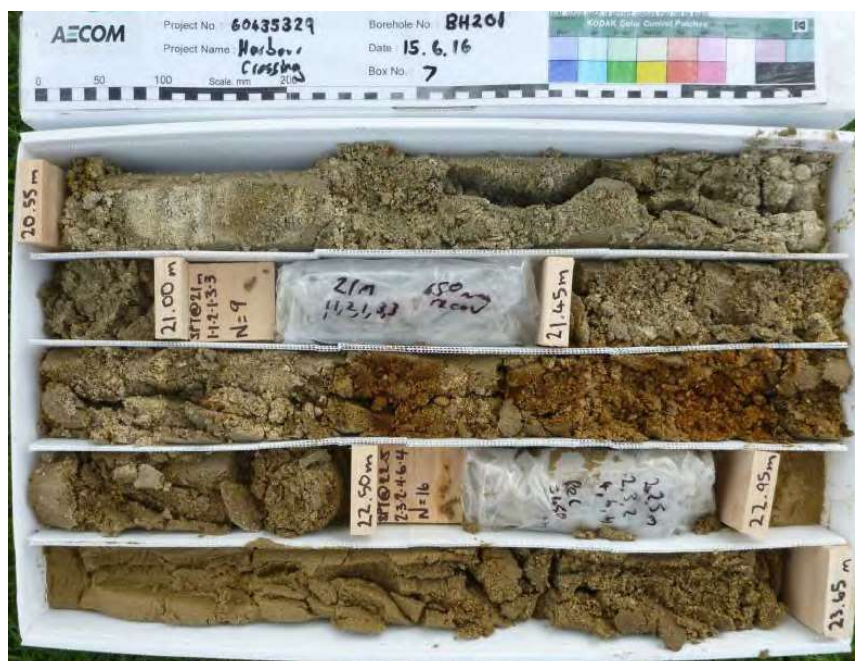
**Box: 7 of 15 - Depth: 20.55m to 23.65m of 49.90m**

HOLE
IDENTIFICATION**BH201**

Date Drilled 14/06/2016 to 16/06/2016

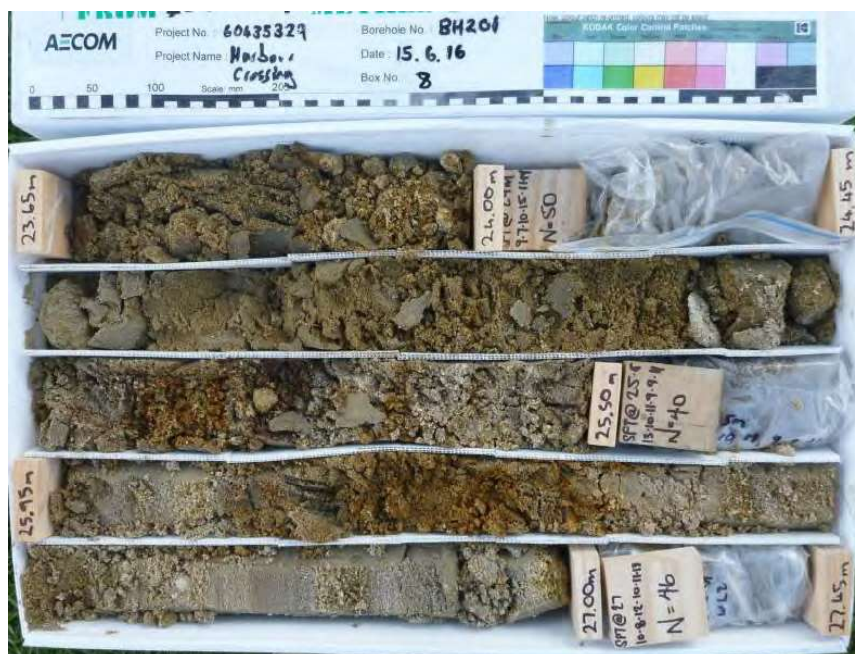
**Box: 8 of 15 - Depth: 23.65m to 27.45m of 49.90m**

Date Drilled 14/06/2016 to 16/06/2016

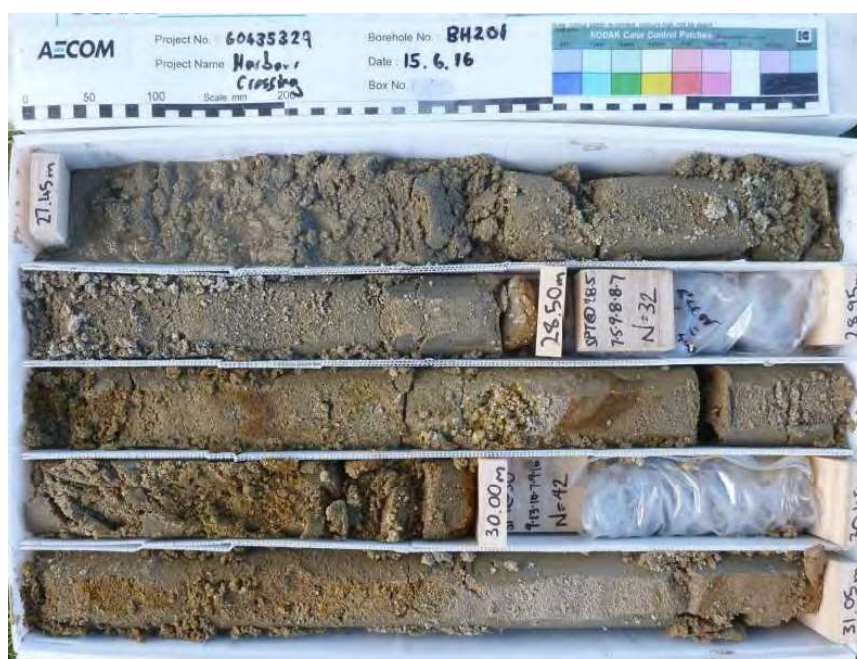
**Box: 9 of 15 - Depth: 27.45m to 31.05m of 49.90m**

HOLE
IDENTIFICATION**BH201**

Date Drilled 14/06/2016 to 16/06/2016

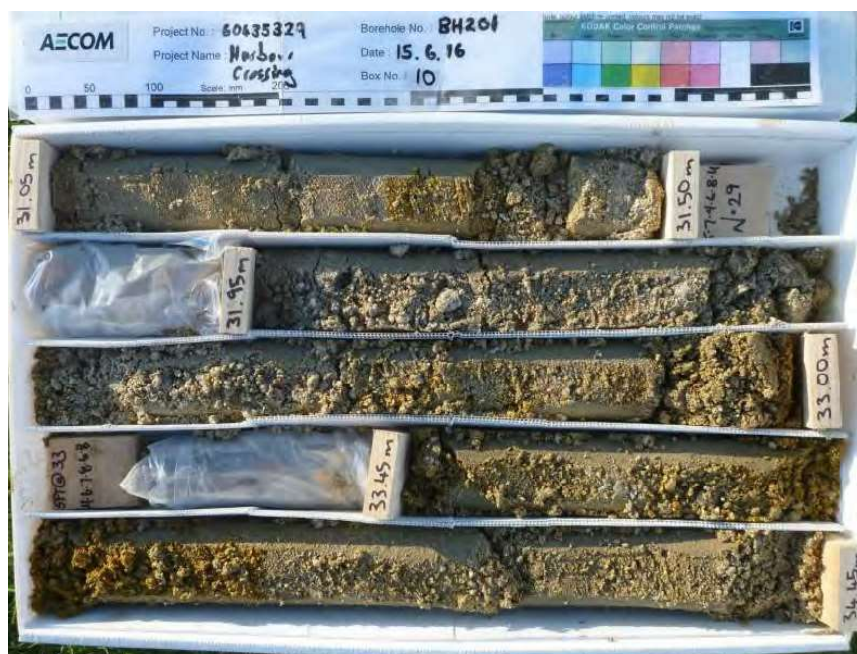
**Box: 10 of 15 - Depth: 31.05m to 34.45m of 49.90m**

Date Drilled 14/06/2016 to 16/06/2016

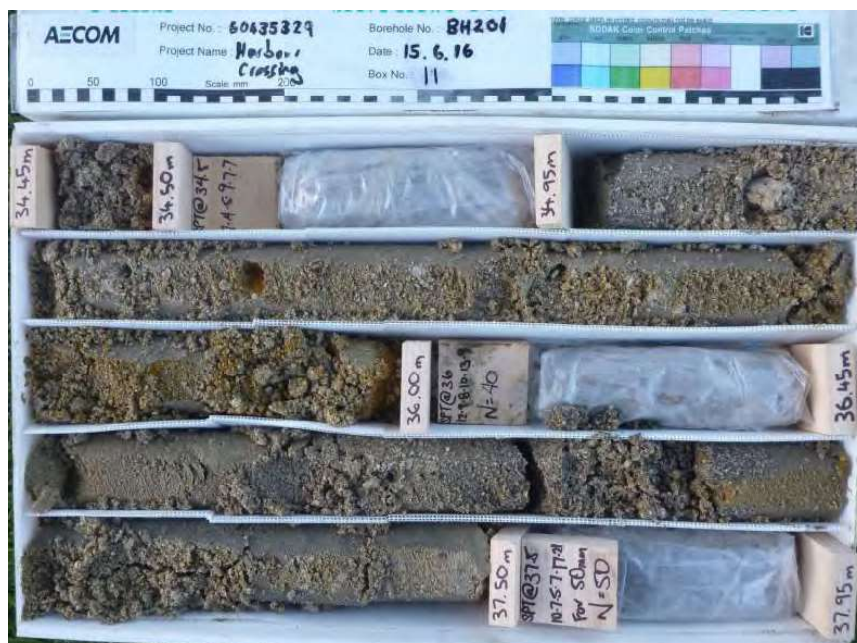
Box: 11 of 15 - Depth: 34.45m to 37.95m of 49.90m

BH201

Date Drilled 14/06/2016 to 16/06/2016

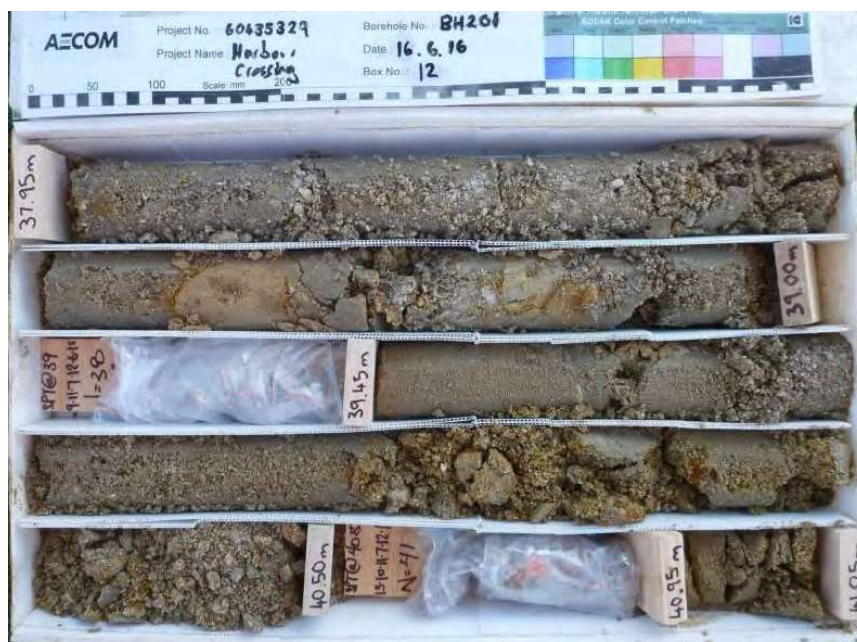
Box: 12 of 15 - Depth: 37.95m to 41.05m of 49.90m

Date Drilled 14/06/2016 to 16/06/2016

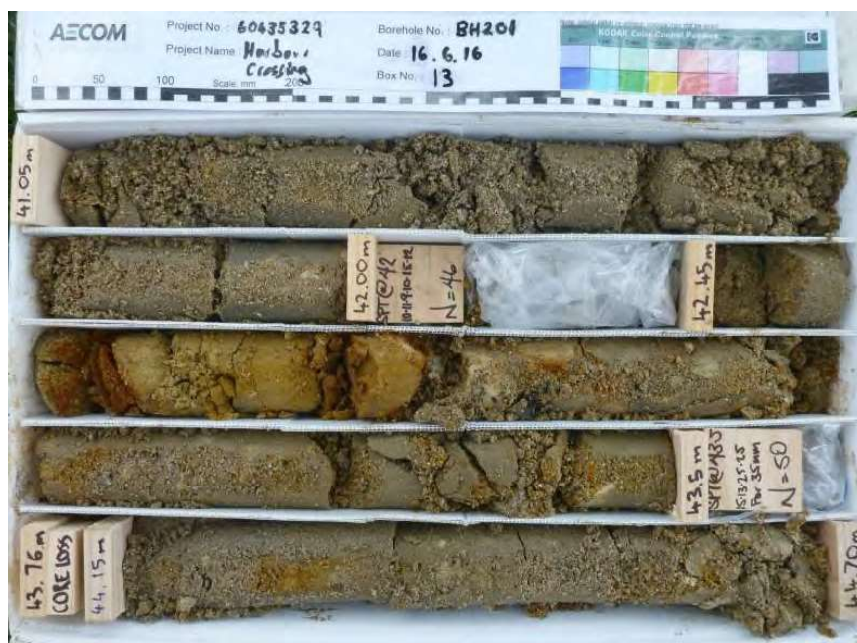
**Box: 13 of 15 - Depth: 41.05m to 44.70m of 49.90m**

HOLE
IDENTIFICATION**BH201**

Date Drilled 14/06/2016 to 16/06/2016

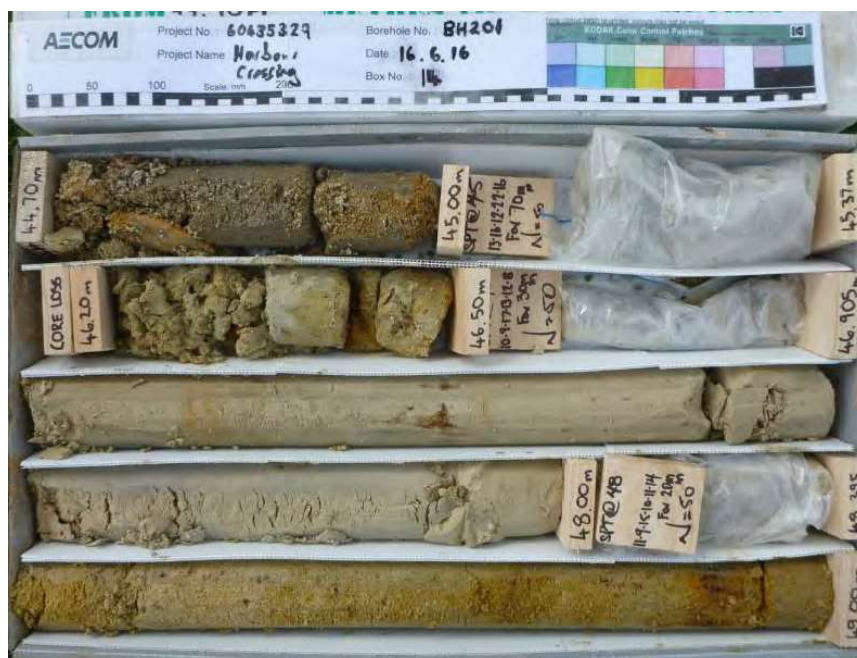
**Box: 14 of 15 - Depth: 44.70m to 49.00m of 49.90m**

Date Drilled 14/06/2016 to 16/06/2016

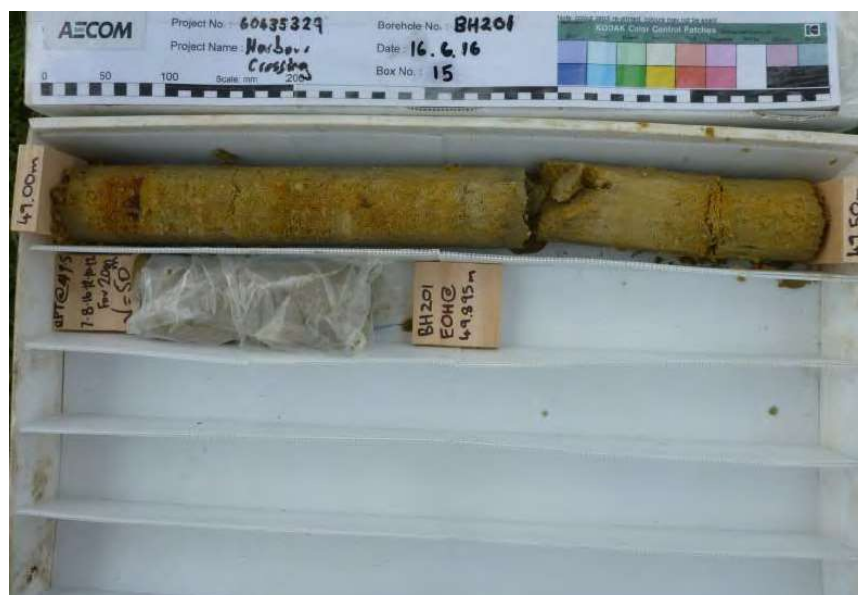
**Box: 15 of 15 - Depth: 49.00m to 49.98m of 49.90m**

HOLE
IDENTIFICATION**BH201**

Date Drilled 14/06/2016 to 16/06/2016

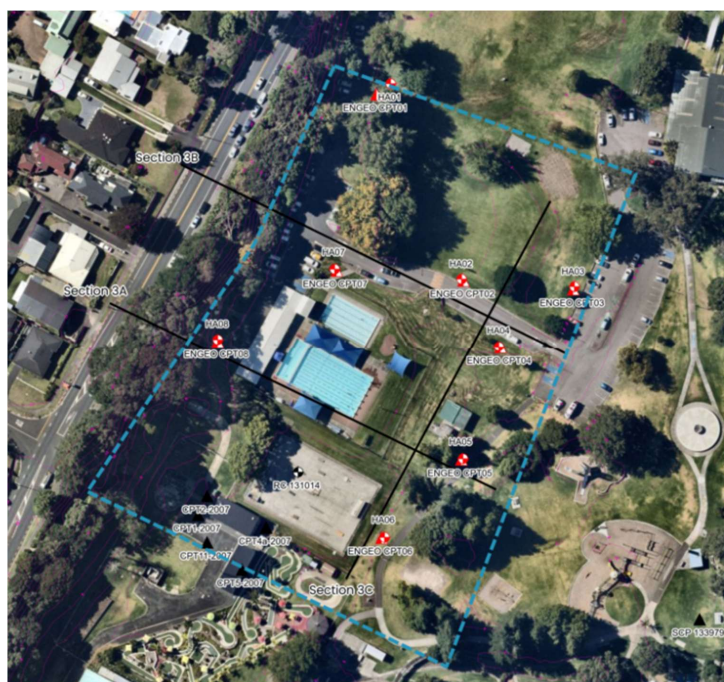
Figure 3: Test Locations (copy from ENGEO summary)

On site deep CPT testing has been completed across the broader area surrounding the current outdoor Memorial Pool. The testing included 8 CPT tests to a depth of 27.8m coupled with shallow hand auger testing.

In general, the testing revealed similar geotechnical conditions as the QEYC site, with softer estuarine deposits of varying thickness overlaying deeper soils. There are layers on non-engineered backfill placement across the site which appears to be related to the construction on the current outdoor pool. To the south, there is an area of higher settlement risk due to deeper soils, that is less suitable for building development. To the West, the natural terrain results in shallower soft soils (lower settlement risk). Heading Northward the subsurface conditions appear relatively uniform. The depth of softer soils continues to increase heading East across the site towards the harbour.

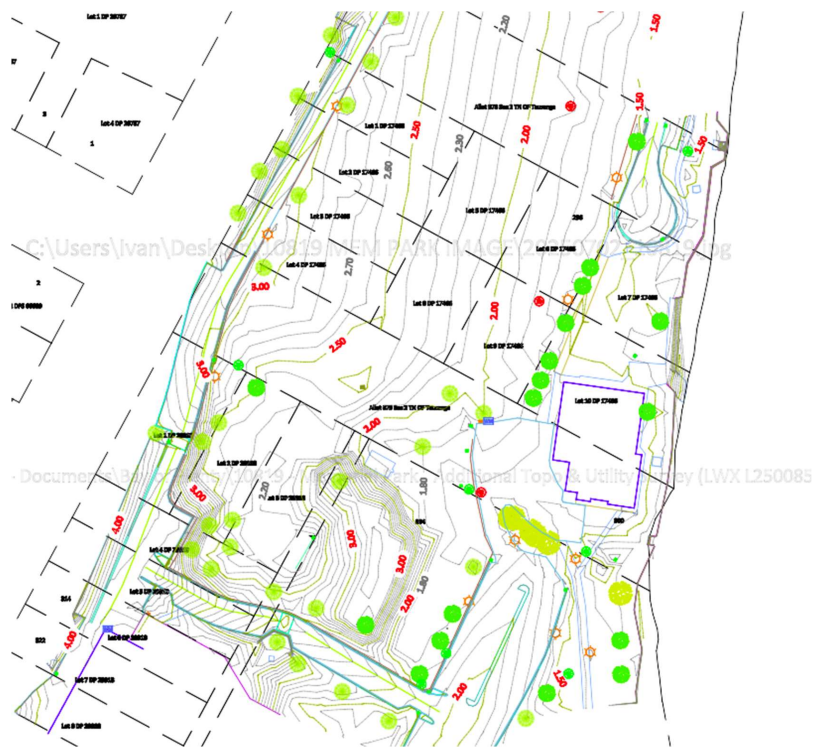
Figure 6: Site topographic survey (copy from Survey Worx)

As noted above, to control overland stormwater flow and comply with planning requirements for coastal inundation the floor level for a new facility is expected to be around 4.3mRL, this is approximately the same level as the existing QEYC building and approximately 600-700mm above the current outdoor pool surface.

The site naturally grades down from West to East from approximately 4.0mRL at the toe of the Devonport Road slope, to 1.3mRL at the shoreline. The site will require filling to achieve a suitable building platform height. Any new development should consider a suitable offset from the shoreline to avoid the need for retaining structures.

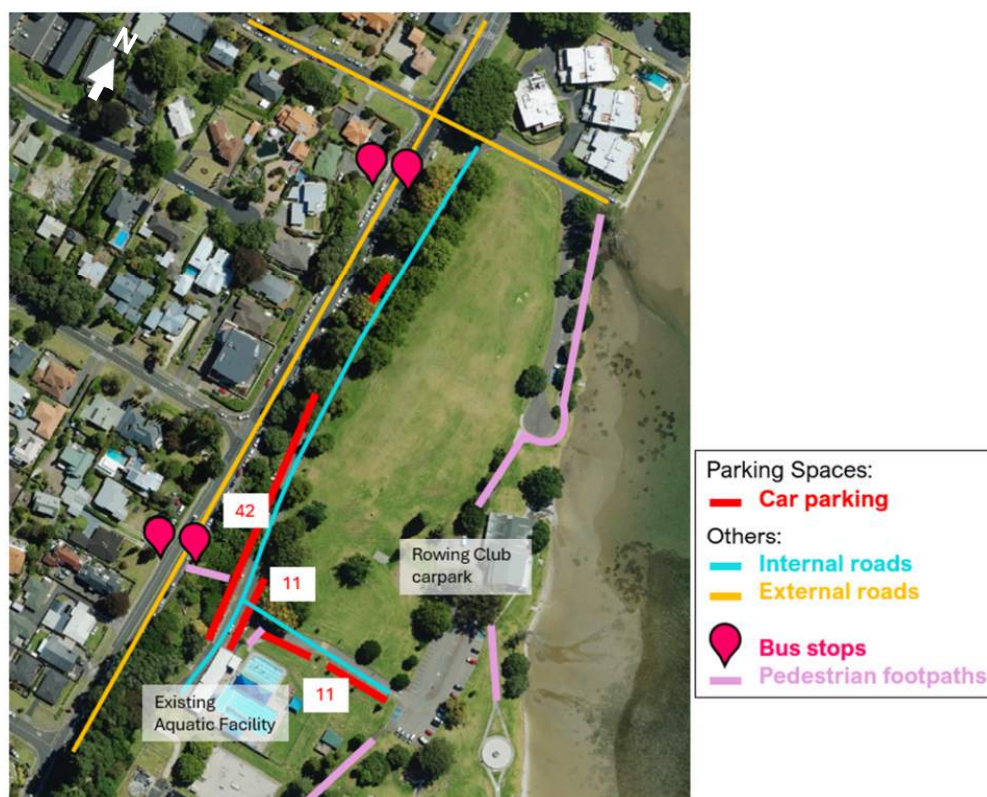
Figure 6 Existing roads, footpaths and parking in Memorial Park

There are two sets of bus stops along Devonport Road which are serviced by route 1 (*Figure 6*). This route travels from Pyes Pa – Greerton – Fraser Cove – Tauranga CBD and operates every 30 minutes.

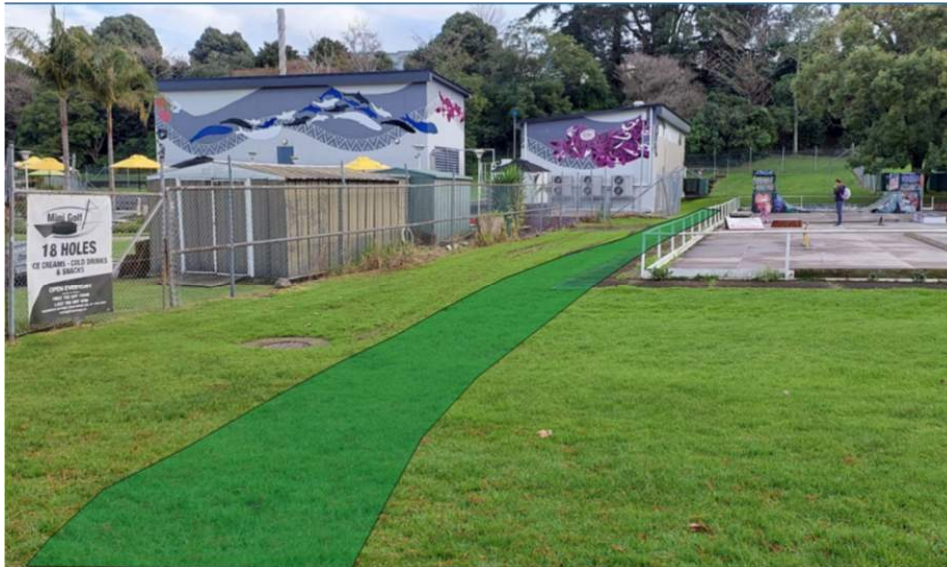
- The OFP through the rowing club parking area should be retained directing flows via the new access road.

Being in the flood prone area, depth x velocity and the compliance with stormwater design requirements in this regard will need consideration.
